## Journal of Engineering Sciences and Innovation

Volume 3, Issue 4 / 2018, pp. 375 - 392

## Guaranteed versus real service life of PV panels in Romania

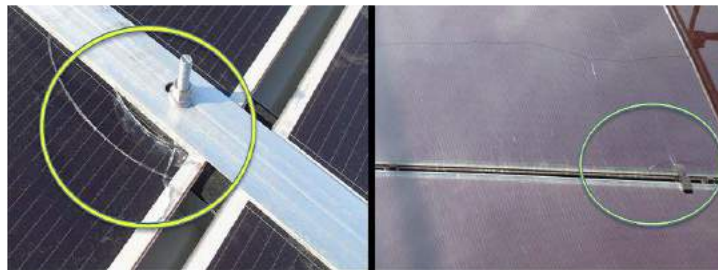
Fig. 4. Defects caused by the gripping system.

The figure on the left shows the glass breakage due to tight screws - faulty execution; the figure on the right shows a gripping system that broke the glass due to the faulty clamping design.

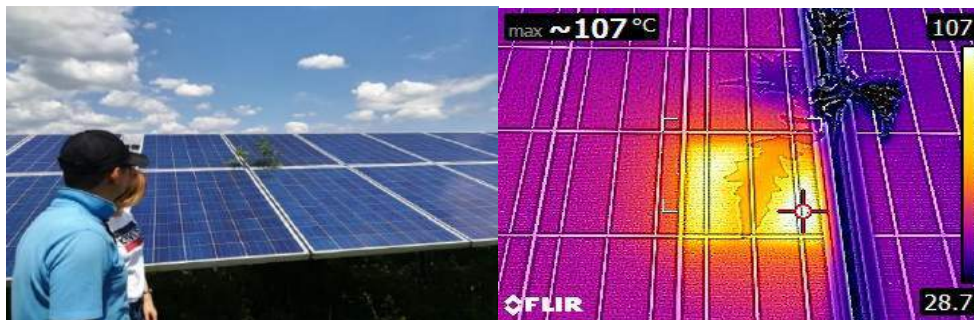
Fig. 8. Hot spot caused by partially shading in PV power plant no.2 - Covasna.

The hot spot generated by the plant that grew under the panel reached 107°C and will destroy the PV cell eventually. During the inspections was discovered that, although corrective maintenance works were being carried out to mow the vegetation between the strings of panels, in all cases the operators did not give importance to the vegetation under the PV panels. This indicates the lack of training of the staff performing the work. The staff and the power plant manager were surprised to find out that a plant that partially shades a module can cause such damage. Thus, urgent measures are required to ensure the quality of preventive maintenance services. In figure 9 can be observed that the grey I-V curve as well as the pink power curve are strongly affected and have irregular shapes. The power of the PV panel decreased by 38.86% compared to the nominal value.

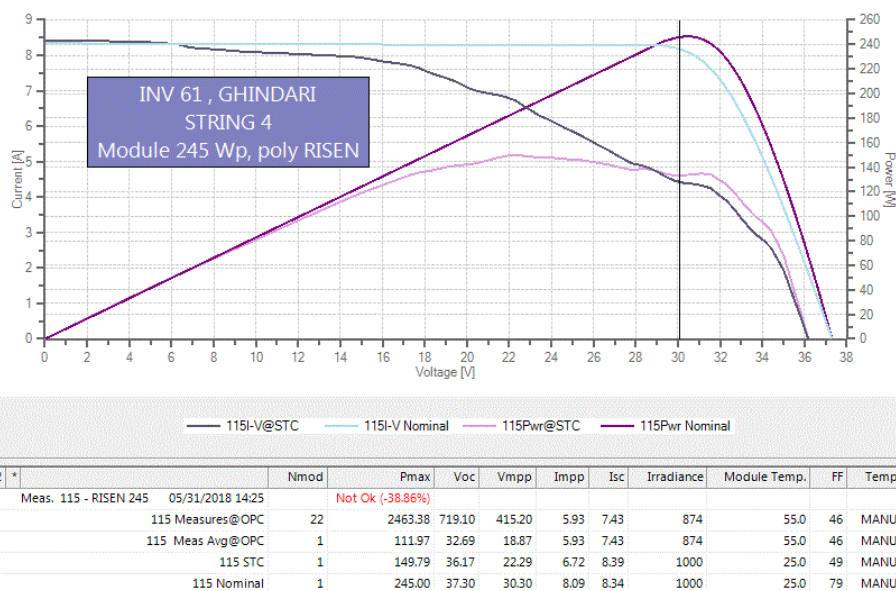
Fig. 9. I-V and power characteristic curve for a shaded PV panel from Mureş power plant no. 3.

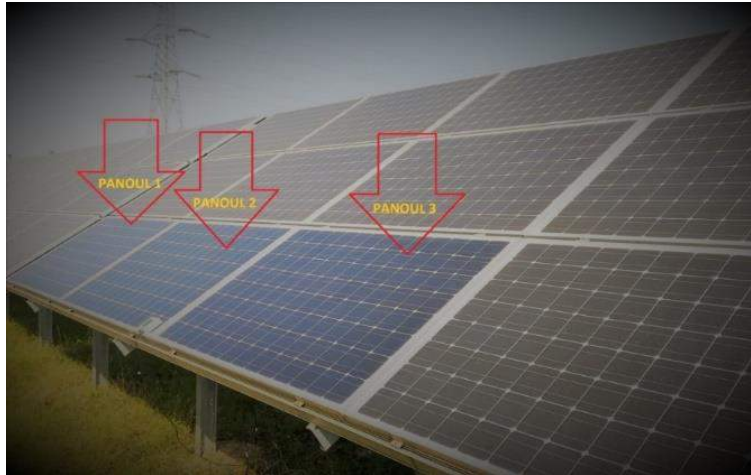
Fig. 10. PV panels comparison between dusty and cleaned panels in Teleorman power plant no. 1.

As can be observed from Figure 10, three panels were chosen from a randomly selected string and cleaned of dust. Measurements were then carried out to determine the current-voltage (I-V) and power-to-voltage (P-V) characteristics before dust removal and after to study the influence on energy production at from Teleorman power plant no.1

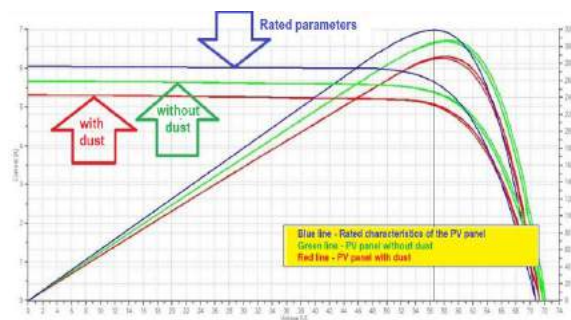
Fig. 11. I-V and power characteristic curve for one PV module with and without dust.

From figure 11 it can be observed that the average of the first measurements shows a degradation of 10% (red curves) and after cleaning the degradation decreases at 4,5% (green curves) falling within normal limits.

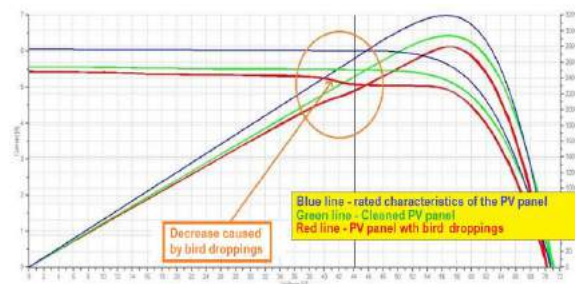
Fig. 14. I-V characteristic curve for one PV module with and without bird droppings.

The I-V characteristic curve determined is shown in Figure 14. The red line shows the decrease caused by bird droppings. After cleaning the panel, the characteristic curve is presented with green line.

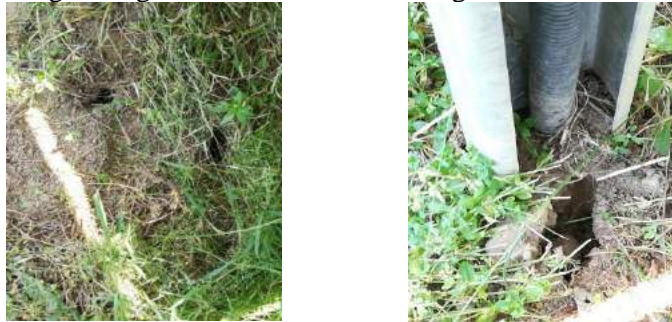
Another deficiency commonly found in PV power plants is the decrease in insulation resistance towards the ground caused by rodents. This defect can also be generated by poor execution (proper insulation and cable layout), non-conforming materials (cable insulation) or even design flaws. Rodent traces from power plant no.4 can be observed in Figure 15. Decreasing the insulation to the ground causes the inverters to enter in protection mode and therefore stop the production. This happens more often in the morning and right after the rain, when the ground is wet.

Fig. 15. Rodent traces found near the cable routes between the strings of PV panels.

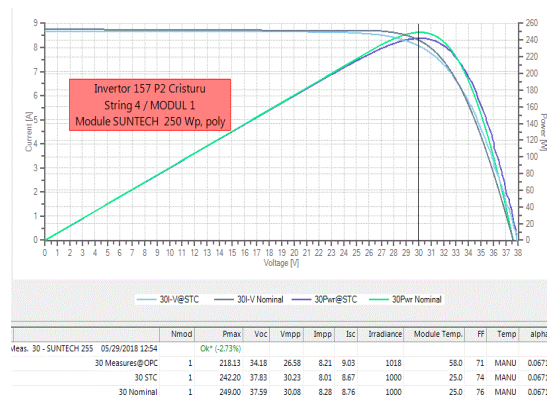
Fig. 16. I-V characteristic curve for one PV module from PV power plant no. 4.

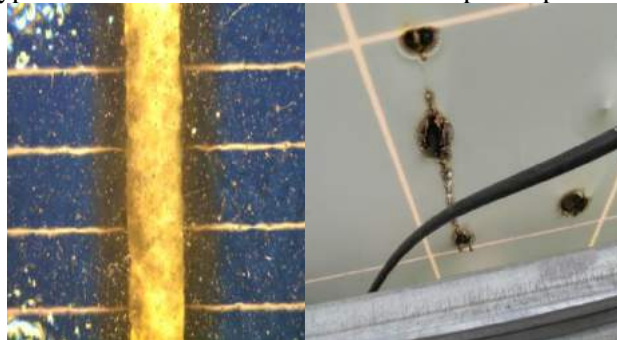
In PV power plant no. 3 the situation is extremely alarming. RISEN panels used on this site are in an advanced degradation state. This causes a degradation of the EVA foil near the ribbon due to a defective manufacturing process (excess flow) or an alloy that degrades rapidly under UV action was used. In time, hot spot occurs that speeds up the damage process and leads to the final destruction of the module. In Figure 17, some defects caused by hot spot are presented. This kind of images are relevant for this type of defect encountered in several PV power plants in the world.

Fig. 17. Degradation of cell connections produces an electric arc or hotspot that causes burning of the back sheet and interrupting the modules string.

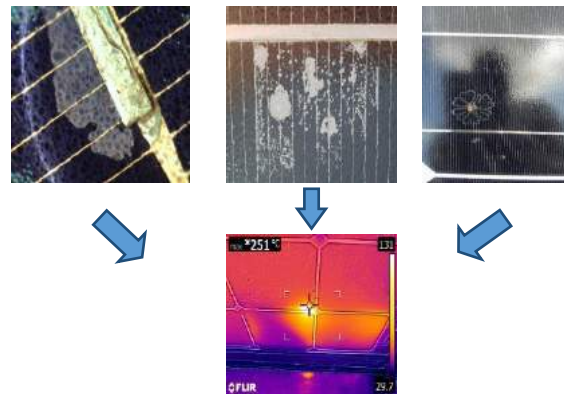
Fig. 18. Hot spot caused by delamination of EVA sheet.

Delamination of the EVA film can cause hot spot and ultimately the destruction of the module. Delamination to the left and centre of the image is due to fingerprints or dust deposited in the manufacturing process and the left one is due to an insect trapped in the encapsulated on the production line.

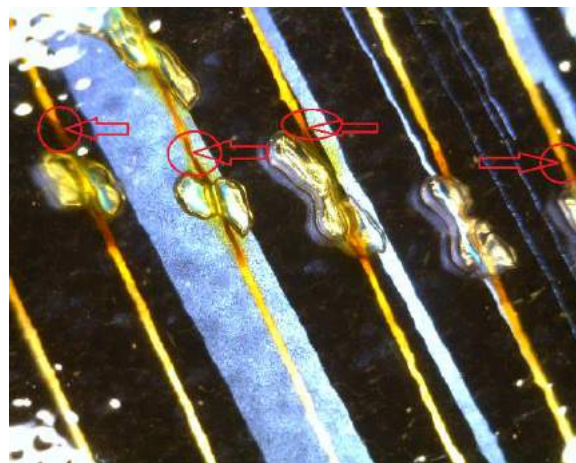
Another manufacturing defect found in PV plant no.5 is damage to cell surfaces and finger interruption (silver wires on the surface of PV cells). The defect is represented in Fig. 19.

Fig. 19. Cell defect caused by excess of soldering flux (image taken with microscopic camera).

During the production process, due to malfunction of the cell straightening equipment, the ribbon remained disconnected by the buss-bar. In this situation, manual soldering of the cell strings was performed using soldering flux.

Excess flux has remained between the EVA sheets and the PV cells. In the lamination process, more precisely in the vacuuming step, the droplets have randomly migrated by flowing streams which have been sealed. It corroded the

finger in time and slowly but surely the hot spot would occur. In the images above from Figure 19 the encapsulated flux droplets can be observed under microscope. A junction box (JB) from PV power plant no.1 has caused the interruption of a string of modules (Figure 19). The degradation of the linkages inside the box was so advanced that the module had to be replaced.

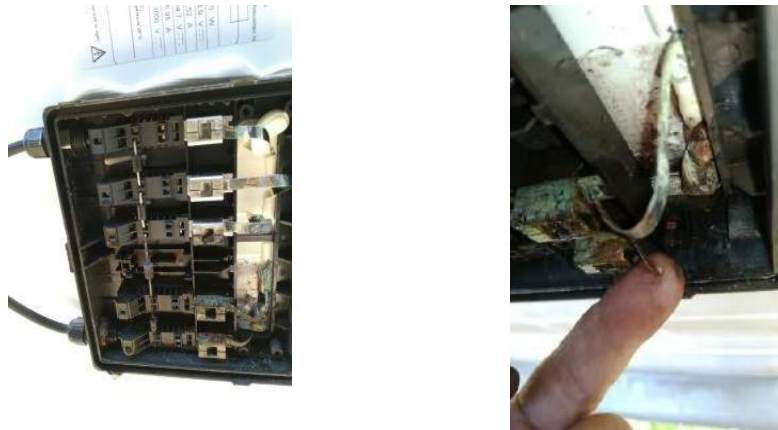
Fig. 20. Damaged junction box by water penetration.

The initial deficiency was the lack of water-tightness that allowed water to infiltrate into the junction box and giving the high current throughput (5A in this case), an electrolysis phenomenon occurred that quickly corroded the metal as the electrodes until the circuit is interrupted. In the 0.6MW PV power plant no.6, the only one visited which has PV modules with thin-film technology (Thin Film) using CIGS (copper, indium, gallium, selenide), the situation is very serious and requires immediate action. After two years of operation, the degradation of the panels is well above the normal limit. Of the 9480 panels of the entire power plant, 444 panels are broken. The severe degradation is caused by numerous factors such as: panel non-compliance, lack of maintenance, poor design and deficient construction. The following images are relevant for the aspects mentioned above (Figure 21).

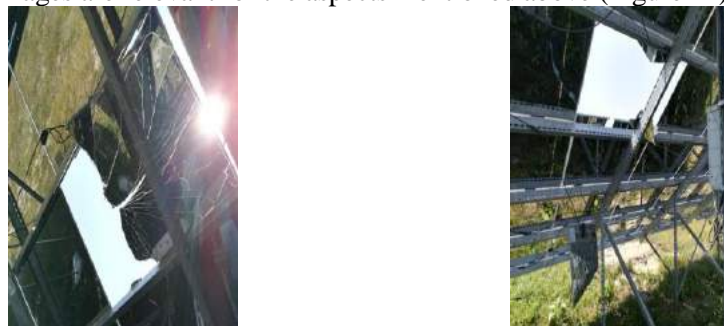
Fig. 21. Broken CIGS panels found at Oşorhei power plant no. 6.

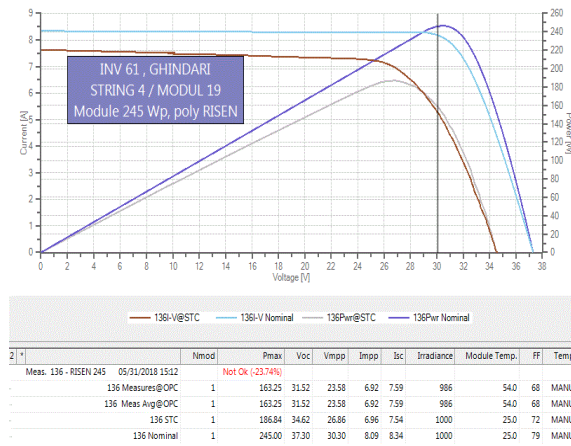
Fig. 22. I-V characteristics measured for a Risen PV panel 245W in 31 may 2018, after 4 years from commissioning.

The I-V characteristic from Figure 22 shows the significant decrease in Voc voltage and short circuit current Isc. It is a consequence of the degradation of the solder alloy (yellowing in fig.17) which has led to the increase of the series resistance of the module, having a direct consequence on the decrease of Isc. The 3V drop of Voc can be attributed to the diffusion of metals (the solder alloy) in the cell structure due to degradation of the passivation layer or the deterioration of the bypass diode, PID or LID phenomenon.

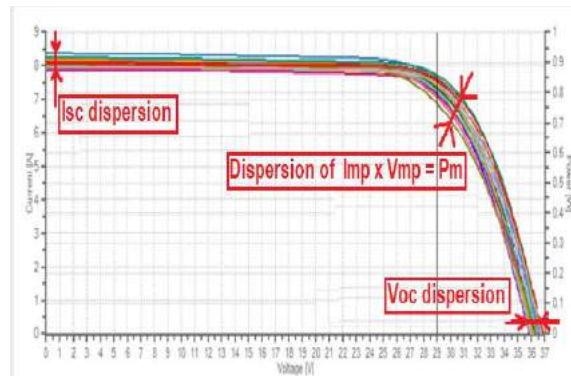
Fig.22. Relatively large dispersion of module parameters in a single string.

Fig.22 shows 22 overlapped I-V characteristics that measures power distribution and mismatch losses on modules in a single string in PV power plant no.3 – Mureş. The PV panels with weaker performances affects the whole string which supplies the inverter.
