Journal of Engineering Sciences and Innovation

CANDU steam generator secondary side fouling characteristics

DUMITRA LUCAN^{1,3*}, GHEORGHITA JINESCU^{2,3}, ALICE DINU¹, MADALINA STANCIULESCU¹, MARIA MIHALACHE¹

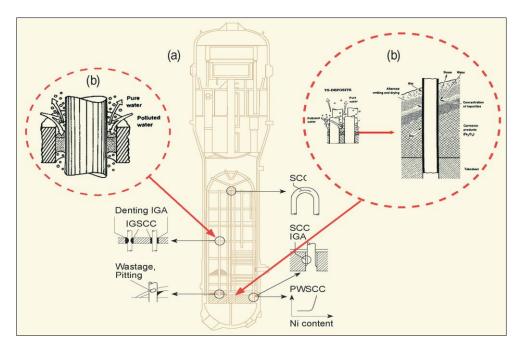
The presence of deposits in the crevices contributes to the concentration of aggressive chemical species within these crevices and therefore contributes to limiting the life of the steam generator, Fig. 1.

Fig. 1. The mechanism of concentration of the impurities in steam generators (a, b); areas affected by corrosion in steam generators (b).

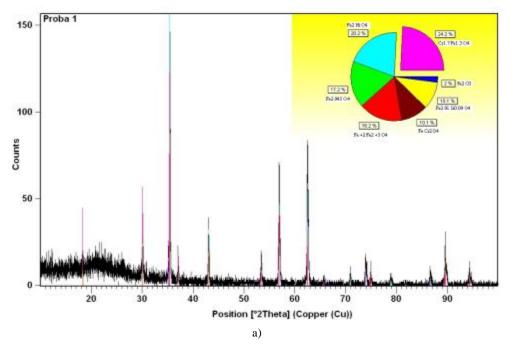
Fig. 3. The diffraction spectrum for sample 1 (a).

Fig. 3. The list of compounds identified by X-ray diffraction (b)

By X-ray diffraction it was found that a high percentage of Fe₃O₄ (~ 16%), Fe_{2.945}O₄ (~17%), FeCr₂O₄ (~ 10%), Fe₂NiO₄ (~ 20%), Cr_{1.3}Fe_{1.7}O₄ (~ 24%). Also, Fe_{2.91}Si_{0.09}O₄ was found to be about 10%. The deposit also contains a very small amount of hematite - Fe₂O₃ (~ 2%).

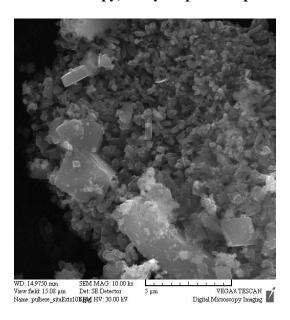
Fig. 4. The deposits morphology determined by SEM.

Fig. 4 shows the morphology of deposits determined by Scanning Electron Microscopy.

The magnetite crystals have rounded edges and this is being explained by the fact that they have not formed inside the steam generator but inside the secondary circuit from where they were transported to the steam generator and because of the flow, the edges have been rounded. Iron is in different oxidation states, darker crystals contain more oxygen in the formula, while lighter crystals contain less oxygen. Particle sizes range from a few microns to tens of microns. In Fig. 5 are presented the point microanalysis (a), the spectra and the quantitative composition of the deposit (b) and (c), which show the presence of Fe -85.63%, Mn -10.15% (this may come from the austenitic steels corrosion process) and Si -3.19%. The presence of silicon in deposits must be followed with great care as it gives hardness to deposits and therefore deposits will be more difficult or impossible to remove from the steam generator by simply cleaning with a pressure water jet, [7] \div [23]. The form of the deposits constituents confirms the presence of both magnetite and hematite and rarely the presence of chromium compounds (oxides and carbides). There are several types of oxides that differ in atomic form and number.

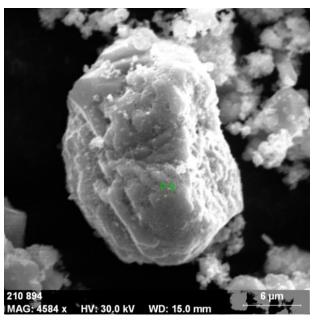
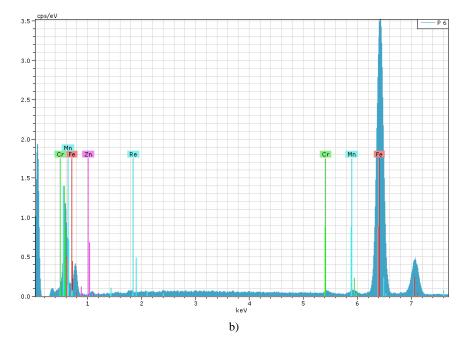
No.	Elements	P6
1	Fe	85.63
2	Mn	10.15
3	Si	3.19
4	Cr	0.79
5	Zn	0.24

Fig. 5. Point microanalysis (a), spectrum and quantitative composition of deposits (b) and (c).

From the point microanalysis, the spectra and the quantitative composition of the deposits, the majority of the iron compounds, especially in the form of oxides, are highlighted. It is noted that in very small amounts of Cr and Ni due to corrosion of

the steam generator tubing material (Incoloy 800), the low corrosion rate of this material explains the presence the small quantities of these elements.
