Journal of Engineering Sciences and Innovation

Volume 3, Issue 4 / 2018, pp. 375 - 392

Guaranteed versus real service life of PV panels in Romania

4. Results of inspections and measurements carried out in PV power plants in Romania

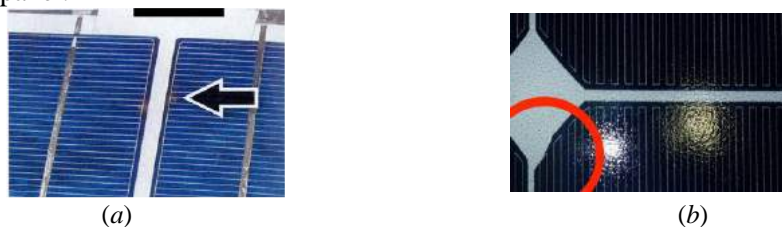
There are also phenomena that occur in production that leave visible traces and may appear as a defect. They are also not considered defective. For example, in Figure 1 there are brown spots at the edges of the solar cells (a) or lightly chipped cell in a PV module (2). These signs come from the solar cell support during the deposition of the anti-reflex layer (a) or the manipulation (b) and are not considered to be failures of the PV panel.

Fig. 1. Brown color traces formed during cell processing (a) and chipped PV cell (b).

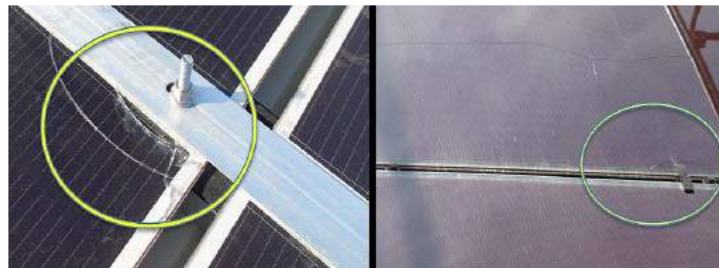
Fig. 4. Defects caused by the gripping system.

The figure on the left shows the glass breakage due to tight screws - faulty execution; the figure on the right shows a gripping system that broke the glass due to the faulty clamping design.

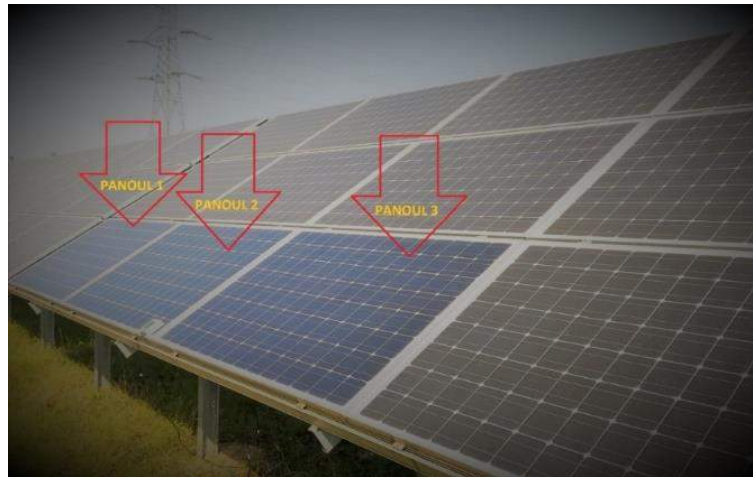
Fig. 10. PV panels comparison between dusty and cleaned panels in Teleorman power plant no. 1.

As can be observed from Figure 10, three panels were chosen from a randomly selected string and cleaned of dust. Measurements were then carried out to determine the current-voltage (I-V) and power-to-voltage (P-V) characteristics before dust removal and after to study the influence on energy production at from Teleorman power plant no.1

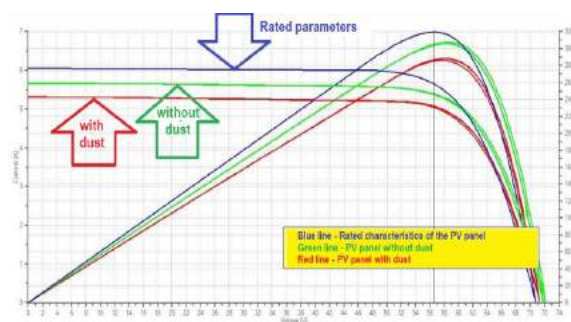
Fig. 11. I-V and power characteristic curve for one PV module with and without dust.

From figure 11 it can be observed that the average of the first measurements shows a degradation of 10% (red curves) and after cleaning the degradation decreases at 4,5% (green curves) falling within normal limits.

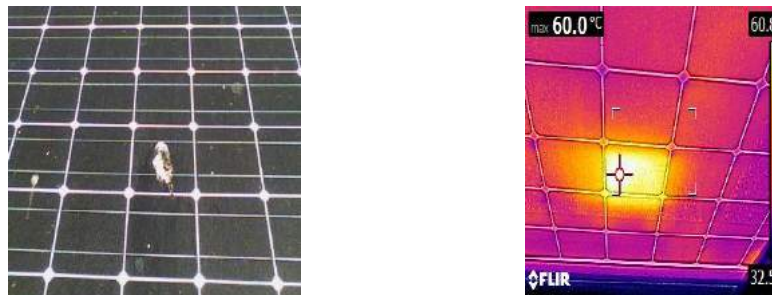
Fig. 13. Picture taken with infrared camera of a PV module with bird droppings.

The camera uses FLIR technology - Forward-Looking Infrared and detects the hot spot formed on the dirty cell. The overheating degrades the structure of the cell in an irreversible way. The faulty cell will cause a malfunction of the whole cells string and the entire PV panel.

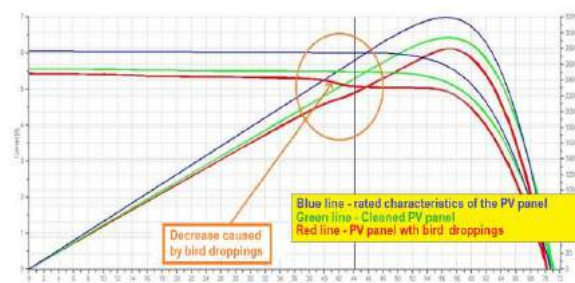
Fig. 14. I-V characteristic curve for one PV module with and without bird droppings.

The I-V characteristic curve determined is shown in Figure 14. The red line shows the decrease caused by bird droppings. After cleaning the panel, the characteristic curve is presented with green line.

- Cleaning of the PV panels for dust and bird droppings generated an increase in production from the initial situation of over 7%, also taking into account mismatch losses caused by the unequal power loss on different panels.
- A non-negligible number of panels affected by hot spot due to bird droppings which in time leads to irreversible degradation of the panels.
- After cleaning, all modules fall within the manufacturer's power limits.

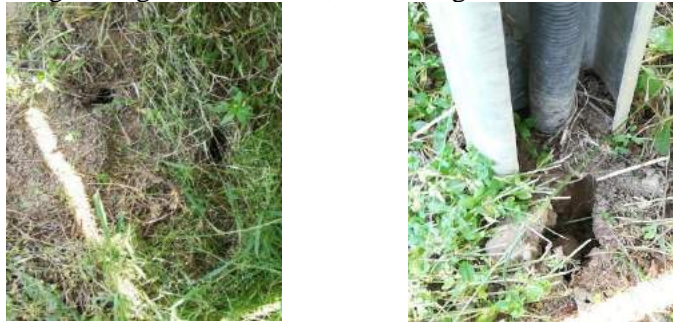
Another deficiency commonly found in PV power plants is the decrease in insulation resistance towards the ground caused by rodents. This defect can also be generated by poor execution (proper insulation and cable layout), non-conforming materials (cable insulation) or even design flaws. Rodent traces from power plant no.4 can be observed in Figure 15. Decreasing the insulation to the ground causes the inverters to enter in protection mode and therefore stop the production. This happens more often in the morning and right after the rain, when the ground is wet.

Fig. 15. Rodent traces found near the cable routes between the strings of PV panels.

Losses caused by reducing the insulation resistance below the protection threshold may be considerable, given that inverters are automatically shut down for a period of several hours (until the ground is dry, or the fault is corrected). In some cases, if the insulation has been destroyed on a larger surface the inverters are forced to shut down permanently.

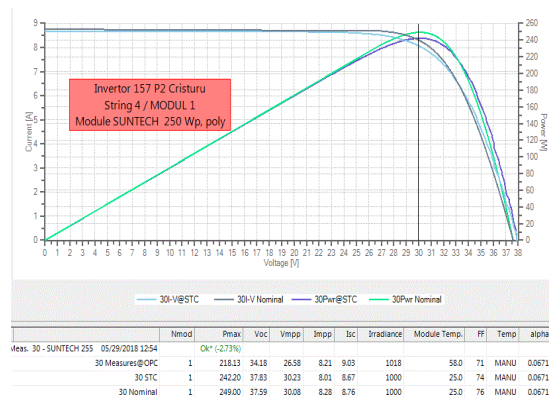
Fig. 16. I-V characteristic curve for one PV module from PV power plant no. 4.

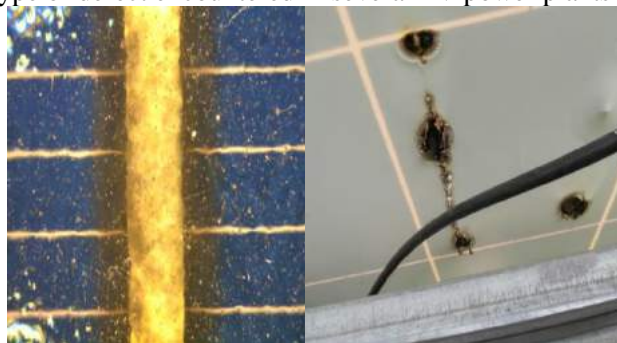
In PV power plant no. 3 the situation is extremely alarming. RISEN panels used on this site are in an advanced degradation state. This causes a degradation of the EVA foil near the ribbon due to a defective manufacturing process (excess flow) or an alloy that degrades rapidly under UV action was used. In time, hot spot occurs that speeds up the damage process and leads to the final destruction of the module. In Figure 17, some defects caused by hot spot are presented. This kind of images are relevant for this type of defect encountered in several PV power plants in the world.

Fig. 17. Degradation of cell connections produces an electric arc or hotspot that causes burning of the back sheet and interrupting the modules string.

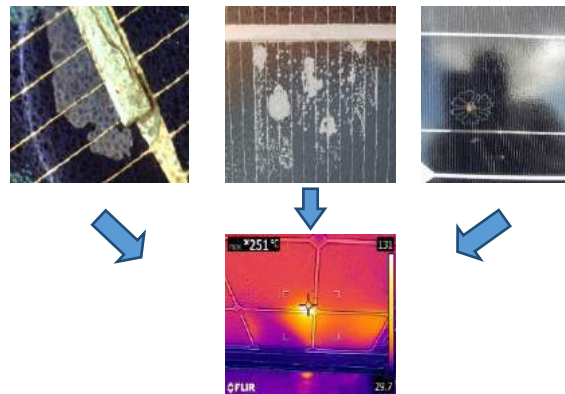
- Operators not using gloves during manufacture leaving fingerprints on the encapsulated foil or ribbon (Fig.18).
- Insects that accidentally are caught between the EVA sheet and PV cells leads to delamination that can also be seen in Figure 18.

Fig. 18. Hot spot caused by delamination of EVA sheet.

Delamination of the EVA film can cause hot spot and ultimately the destruction of the module. Delamination to the left and centre of the image is due to fingerprints or dust deposited in the manufacturing process and the left one is due to an insect trapped in the encapsulated on the production line.

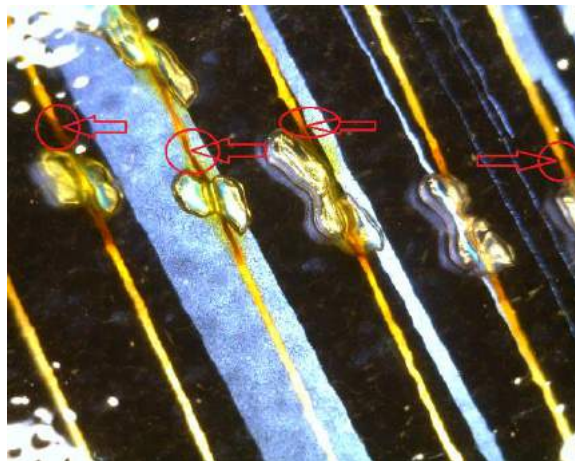
Another manufacturing defect found in PV plant no.5 is damage to cell surfaces and finger interruption (silver wires on the surface of PV cells). The defect is represented in Fig. 19.

Fig. 19. Cell defect caused by excess of soldering flux (image taken with microscopic camera).

During the production process, due to malfunction of the cell straightening equipment, the ribbon remained disconnected by the buss-bar. In this situation, manual soldering of the cell strings was performed using soldering flux.

Excess flux has remained between the EVA sheets and the PV cells. In the lamination process, more precisely in the vacuuming step, the droplets have randomly migrated by flowing streams which have been sealed. It corroded the

finger in time and slowly but surely the hot spot would occur. In the images above from Figure 19 the encapsulated flux droplets can be observed under microscope. A junction box (JB) from PV power plant no.1 has caused the interruption of a string of modules (Figure 19). The degradation of the linkages inside the box was so advanced that the module had to be replaced.

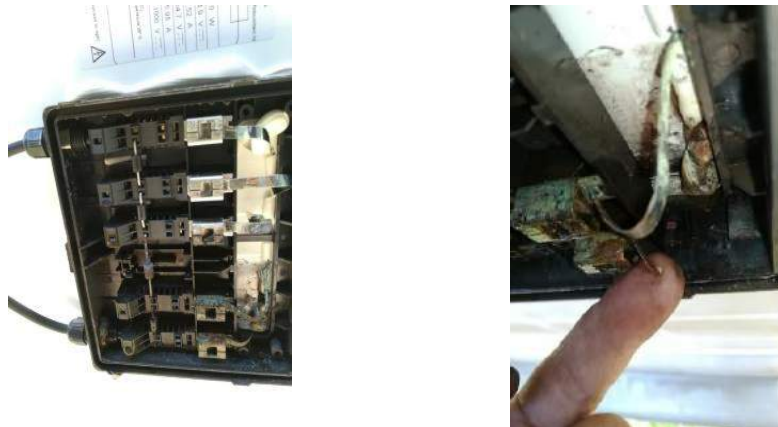
Fig. 20. Damaged junction box by water penetration.

The initial deficiency was the lack of water-tightness that allowed water to infiltrate into the junction box and giving the high current throughput (5A in this case), an electrolysis phenomenon occurred that quickly corroded the metal as the electrodes until the circuit is interrupted. In the 0.6MW PV power plant no.6, the only one visited which has PV modules with thin-film technology (Thin Film) using CIGS (copper, indium, gallium, selenide), the situation is very serious and requires immediate action. After two years of operation, the degradation of the panels is well above the normal limit. Of the 9480 panels of the entire power plant, 444 panels are broken. The severe degradation is caused by numerous factors such as: panel non-compliance, lack of maintenance, poor design and deficient construction. The following images are relevant for the aspects mentioned above (Figure 21).
