## **Safety of a historical Dam in Romania**

**DAN STEMATIU<sup>1\*</sup>, ALTAN ABDULAMIT<sup>2</sup>**

## **2. Taul Mare Dam general information**

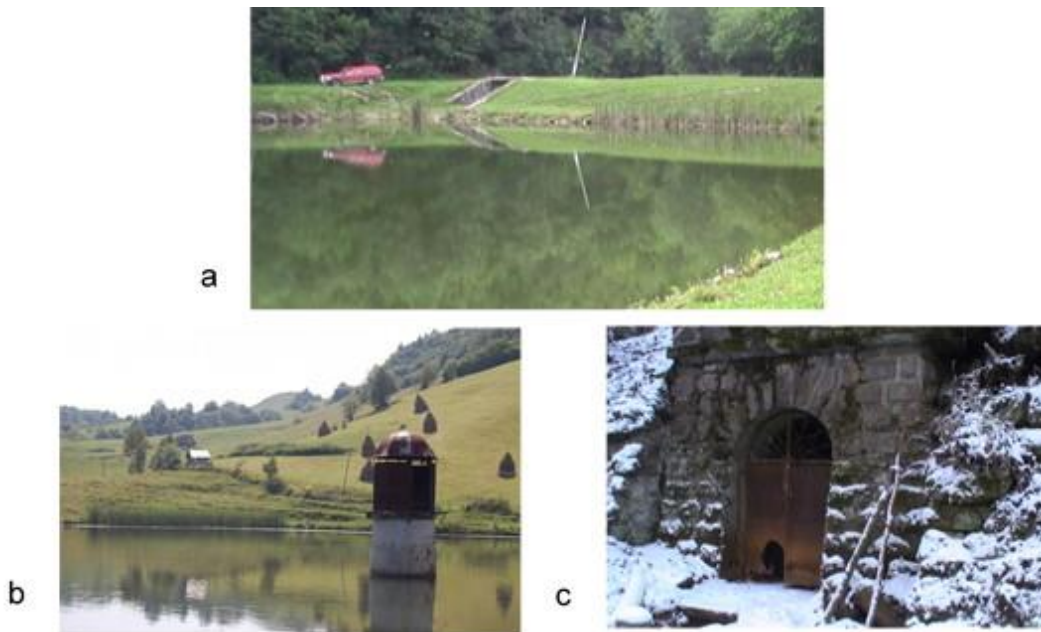
Fig. 4. Taul Mare Dam appurtenant structures;  
a – spillway; b – bottom outlet tower intake; c – bottom outlet gallery exit portal.

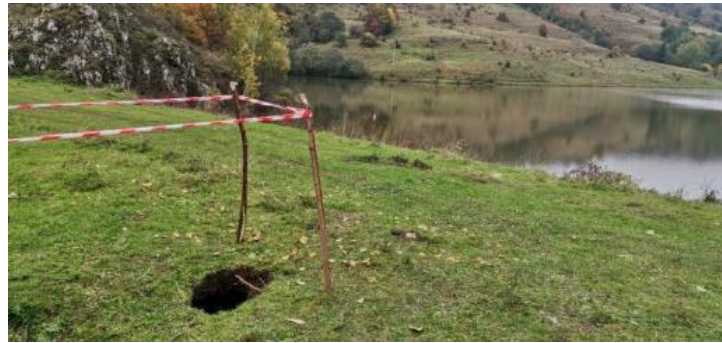
The incident was noticed on the 1st of October 2022 and apparently was prompted by a sinkhole revealed on the dam crest, some 1-2 m from the downstream face. The hole had a diameter of 50-60 cm at the crest surface and up to 1.50 m in depth (Fig. 5).

Fig. 5. Sinkhole at dam's crest during Taul Mare Dam incident (Oct. 2022).

Considering the sinkhole as a sign of an incipient dam failure, the local authorities started emptying of the reservoir and demanded for the evacuation of the downstream village people living in the potential flooding area.

Consequently, among the proposed dam restoration works one can mention the most important: relining the bottom outlet gallery using the same type of stone

lining; filling up the chimney hole; replacing the outlet conduit with a new one, rebuilding the buttresses at the downstream face, cleaning the dam faces etc. Subsequent investigations will allow for a possible relocation of the bottom outlet intake elevation, due to the thick layer of sediments in the reservoir. Obviously, the dam needs post analyses to assess the safety status, both structural and related to the capacity of flood routing according to present day's conditions. Since the dam is included in the list of UNESCO world inheritance sites, the technical solutions will have to preserve the type, materials and appearance of the ancient structures and the design project will be approved by The Romanian National Commission of Historical Monuments (Ministry of Culture, National Institute of Patrimony 2022).

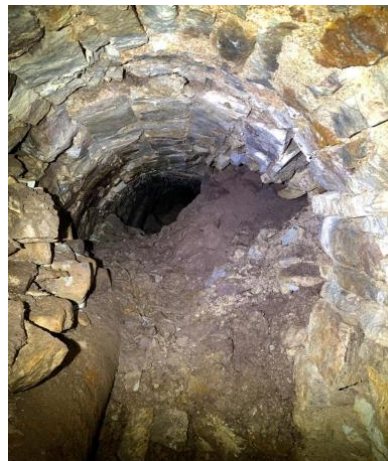
A thorough technical inspection was made in the following days. The most relevant findings were revealed in the gallery of the bottom outlet pipeline (Sofronie 2022). A local deposit of gravel with a length of some 6 m, created by the collapse of gallery lining was discovered (Fig. 6).

Fig. 6. Local failure of bottom outlet gallery.

Fortunately, the failure had no connection with the reservoir, since no seepage was encountered. Based on these findings the incident mechanism was clarified. The influx material in the failed zone of the gallery originated from the dam body. Apparently, an unstable “chimney” was opened in the earthfill dam body after the gallery lining collapse, propagated up towards the vicinity of the dam crest (Fig. 7).

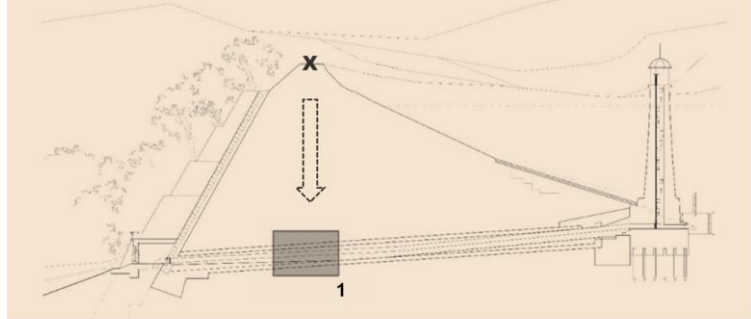
Fig. 7. Mechanism of local failure of bottom outlet gallery; X – sinkhole; 1 – bottom outlet gallery lining collapse.

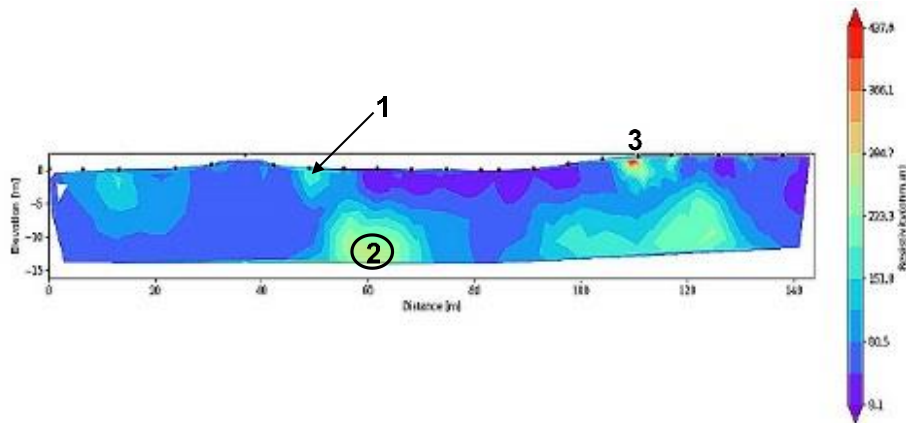
Geophysical investigations using electrical resistivity imaging (ERI) were performed to verify the dam body integrity. The results presented in figure 8 have shown that there were no other cavities within the earthfill mass (Mihai et al. 2022).

Fig. 8. Electrical resistivity imaging (ERI) investigations interpretation; 1 – approx. location of crest sinkhole; 2 – bottom outlet gallery; 3 – rock abutment
