Journal of Engineering Sciences and Innovation

Safety of a historical Dam in Romania

DAN STEMATIU^{1*}, ALTAN ABDULAMIT²

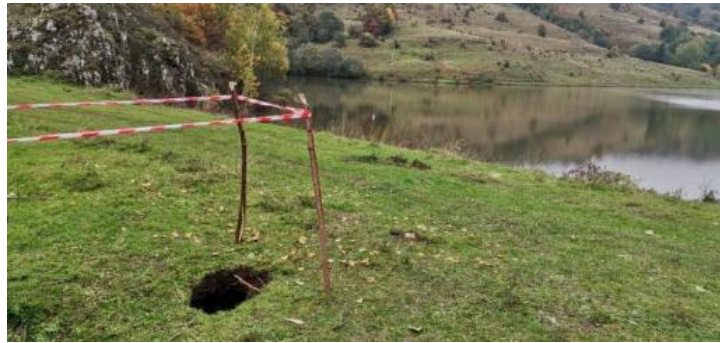
The incident was noticed on the 1st of October 2022 and apparently was prompted by a sinkhole revealed on the dam crest, some 1-2 m from the downstream face. The hole had a diameter of 50-60 cm at the crest surface and up to 1.50 m in depth (Fig. 5).

Fig. 5. Sinkhole at dam's crest during Taul Mare Dam incident (Oct. 2022).

Considering the sinkhole as a sign of an incipient dam failure, the local authorities started emptying of the reservoir and demanded for the evacuation of the downstream village people living in the potential flooding area.

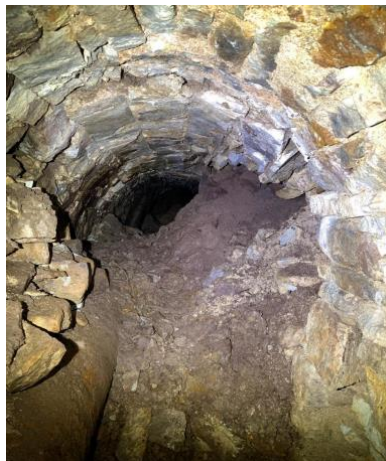
A thorough technical inspection was made in the following days. The most relevant findings were revealed in the gallery of the bottom outlet pipeline (Sofronie 2022). A local deposit of gravel with a length of some 6 m, created by the collapse of gallery lining was discovered (Fig. 6).

Fig. 6. Local failure of bottom outlet gallery.

Fortunately, the failure had no connection with the reservoir, since no seepage was encountered. Based on these findings the incident mechanism was clarified. The influx material in the failed zone of the gallery originated from the dam body. Apparently, an unstable “chimney” was opened in the earthfill dam body after the gallery lining collapse, propagated up towards the vicinity of the dam crest (Fig. 7).

Consequently, among the proposed dam restoration works one can mention the most important: relining the bottom outlet gallery using the same type of stone

lining; filling up the chimney hole; replacing the outlet conduit with a new one, rebuilding the buttresses at the downstream face, cleaning the dam faces etc. Subsequent investigations will allow for a possible relocation of the bottom outlet intake elevation, due to the thick layer of sediments in the reservoir. Obviously, the dam needs post analyses to assess the safety status, both structural and related to the capacity of flood routing according to present day's conditions. Since the dam is included in the list of UNESCO world inheritance sites, the technical solutions will have to preserve the type, materials and appearance of the ancient structures and the design project will be approved by The Romanian National Commission of Historical Monuments (Ministry of Culture, National Institute of Patrimony 2022).

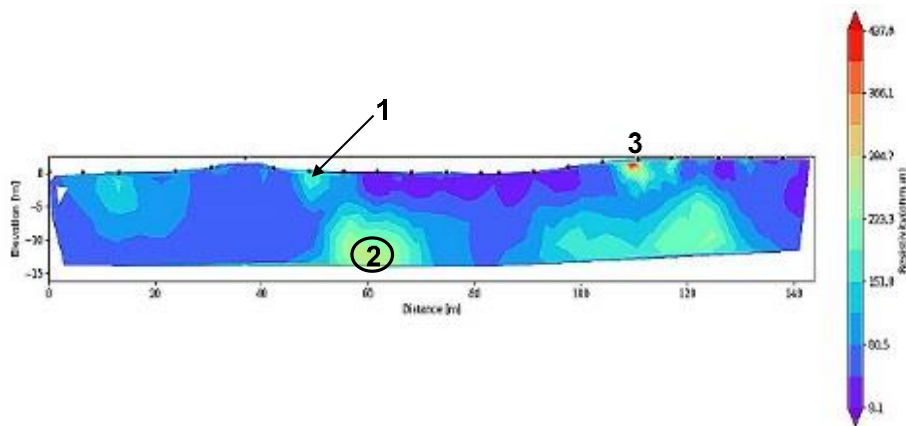
Geophysical investigations using electrical resistivity imaging (ERI) were performed to verify the dam body integrity. The results presented in figure 8 have shown that there were no other cavities within the earthfill mass (Mihai et al. 2022).

Fig. 8. Electrical resistivity imaging (ERI) investigations interpretation; 1 – approx. location of crest sinkhole; 2 – bottom outlet gallery; 3 – rock abutment
