Journal of Engineering Sciences and Innovation
Volume 2, Issue 1 / 2017, pp. 121-136

ASPECTS ABOUT THE INFLUENCE OF THE DIFFERENT FACTORS IN FAMOUS COLLAPSE OF ROOF CONCRETE STRUCTURES

Abstract. In this paper there are presented the influence of the various parameters which could be involved in the collapse of the roof concrete structures of the Cluj Sports Hall in February 15th 1961 soon after the total solar eclipse. This study takes into consideration the multiple causes for the collapse include the thermal shock due to the solar eclipse, the inappropriate projection of the roof and the cracks in the structure after winter and exactly the rain conditions in previous night of the collapse. This parameters where involved in modeling the structure with SCIA Engineer v16.0. The conclusions of this study reveals as a major factor for collapse the rising the weight of the roof structure due to water accumulation in the cracks of the roof and the secondary cause the superposition of the specific thermal field due to the total solar eclipse. Using the Energonics principles, the superposition of the two main loads (mechanical and thermal), there were performed a lot of iterations in ET

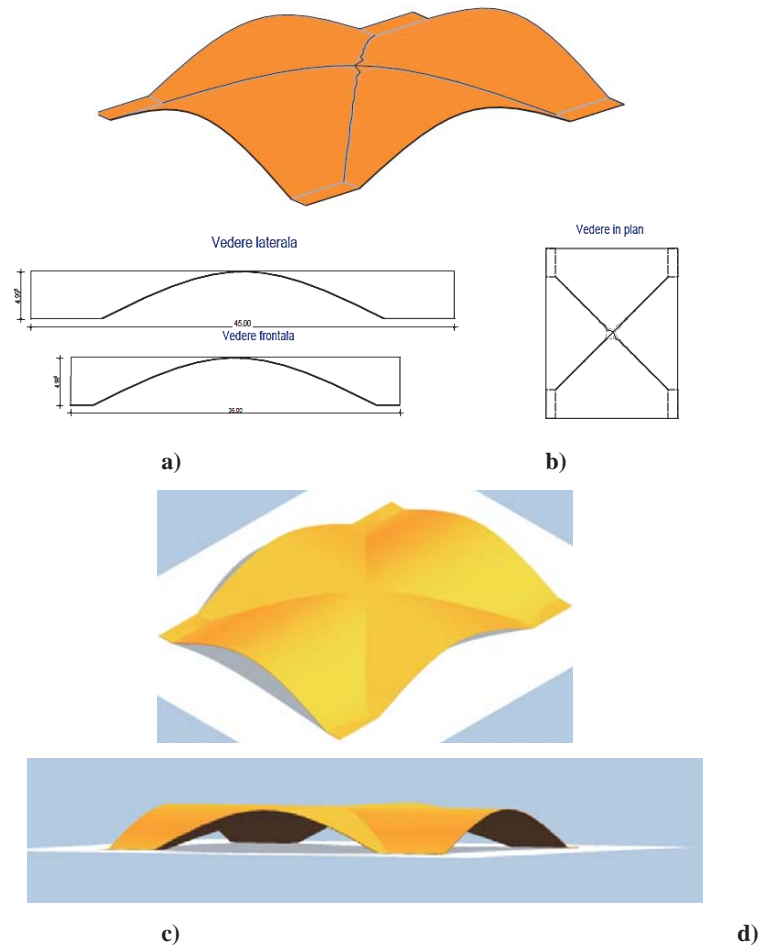
Fig. 3. The design of the thin concrete shell roof for Sports House.

The design of a Thin Concrete Shell Roof is presented in figure 3 and consists in the following elements:

- The structure was **reinforced-concrete monolithic thin shell**;
- The Contour support of the roof were made by **concrete-prestressed beams**;
- The roof (roof covering), thin cloth made of two intersecting horizontal cylinder all-concrete monolith.

- At the intersection, are created on the diagonal, ellipse arches. These arches should have been calculated accordingly. The issue is not so simple, because these arches had the section as "a butterfly with open wings" in order to achieve takeover efforts, resulting in intersection the two cylinders. It seems that here, it would have been the main error of design process, because the calculation had been simplified, reducing the section of the arches at a segments type polyline. [12]

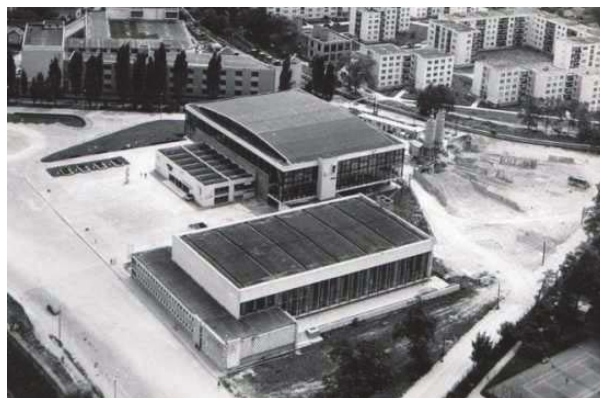
Fig. 4. The top view of the new building - Sports Hall officially opened in 1965 – rear end [8].

For rebuilding process, it was then decided that the roof will be metal farms structure presented in figure 4.

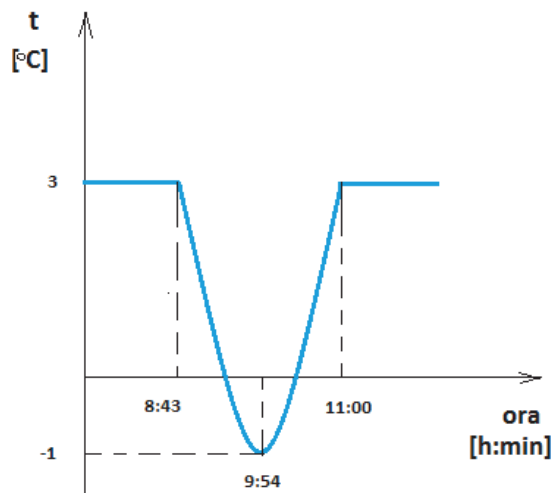
Fig. 5. Temperature function during the eclipse.

The temperature of the air during the eclipse can be considered to be modeled with the graphic from the fig. 5. Using the medium temperature for Cluj, in February 1961, and the testimony of some witnesses of that times were combined the parameters involved. Using the observed difference during some phenomenon – the total solar eclipse, inside of the town, in a place not sheltered, as ours, the maximum **thermal shock** can be taken to be likely 4°C.

For the complete analysis the superposition between the thermal loads and mechanical loads (permanent and exceptional loads – from the big amount of water of the previous rainfall) needs to be taken into consideration and used as input data in the correct and complete analysis. The law of the equivalence of processes and phenomena: “Any two phenomena, at a given time, are equivalent if the total participation of their involved specific energy, compared to the same critical state, are equal. Generally one should write $P_{T,1}(t) = P_{T,2}(t)$, where $P_{T,1}(t)$, $P_{T,2}(t)$ is total specific energy participation dependent on time, t , for process 1 and for process 2. Both or only one of this participations may be time independent.[16]. In our case the thermal process can be time dependent (see the graphic from the fig. 5).

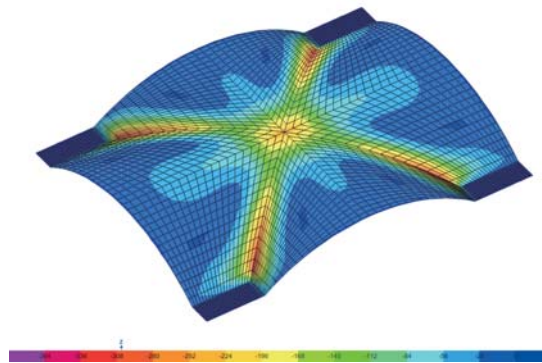
Fig. 6, a) Direct force per unit length acting at the mid-surface of the element on the positive and negative 1 faces in the 1-axis direction.

Performing the analysis the important conclusions can be done. The most loaded areas are the intersections of the quarter-shells and the intersection between supports area and the roof structure main diagonals.

In the figure 6 a) the direct force per unit length acting at the mid-surface of the element on the positive and negative 1 faces in the 1-axis direction is indicated as a map. Is visible that the maximum recorded values are located on the intersections - 364 kN/m. The figure 6b represents the Fmin – for the elements, the maximum value is 845 kN/m.

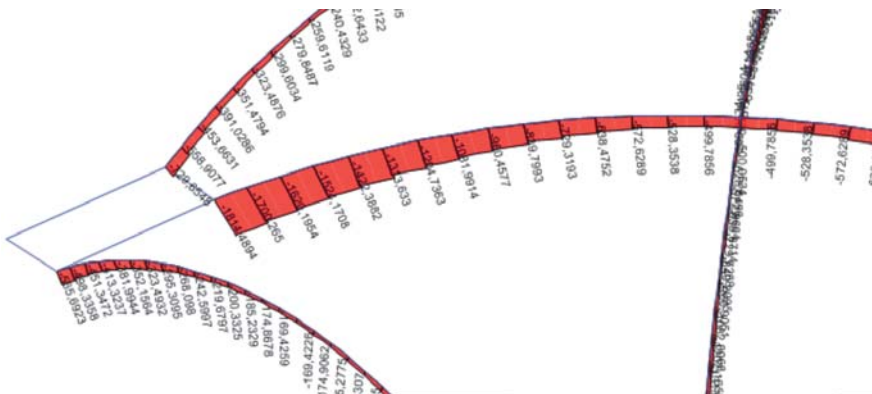
Fig. 7. The Faxial diagram for the entire roof structure.

Fig. 7 represents Faxial diagram with the maximum values from the leaning surface is 1814 KN/m and the figure 8 represents the shear - direct stress (force per unit area) acting on the positive and negative 2 faces in the 2-axis direction. The maximum value is 1814.48kN/m² and it is located on the inside corners of the leaning surfaces.

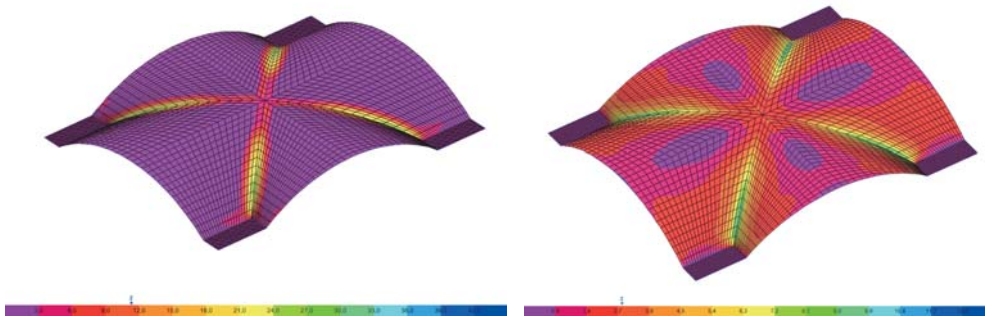
Fig. 9 a) Vmax - Maximum principal shear per unit length acting at the mid-surface of the element; b) SVM - Von Mises principal stress (force per unit area).

The figure 9 a) shows the maximum principal shear per unit length acting at the mid-surface of the element, with the maximum value of 42.0kN/m and the figure 9 b) shows Von Mises principal stress (force per unit area) for the entire structure. The maximum value is 12.6 kN/m² located on the supports area.

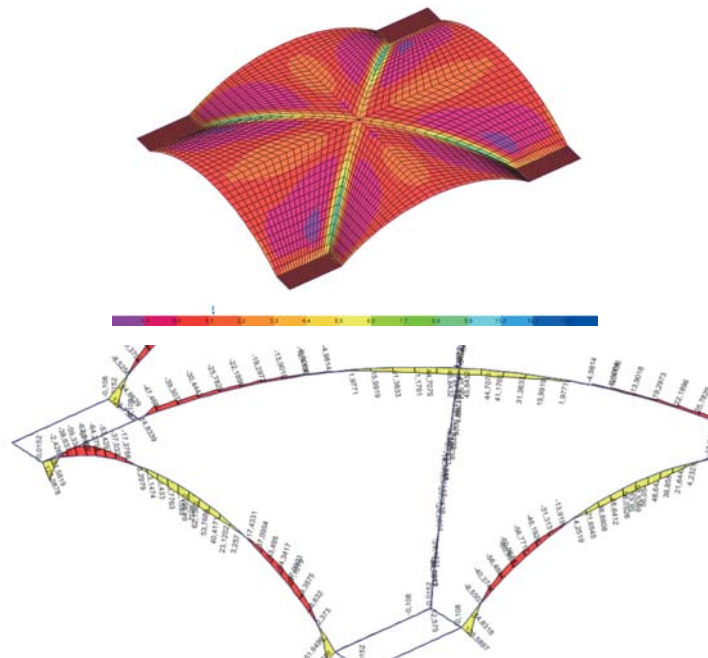
Fig. 10a) M11 - Direct moment per unit length acting at the mid-surface of the element on the positive and negative 1 faces about the 2-axis; b) M 33 –Load case combining maximum value of V22 and M33.

The fig. 10 a) represents M11 diagram of moments - direct moment per unit length acting at the mid-surface of the element on the positive and negative 1 faces about the 2-axis. The maximum value is 8.50kNm and it is located on the intersection of the quarters of the model.

The M33 maximum vaue (fig. 10 b) is 125.878 kNm and it is located on the four supports.

Figure 10 b) with M33 diagram shows the high values of the moment and the cutting force in the support. Most of the failures that occur in a roof system are not major collapses, but simply performance failures.

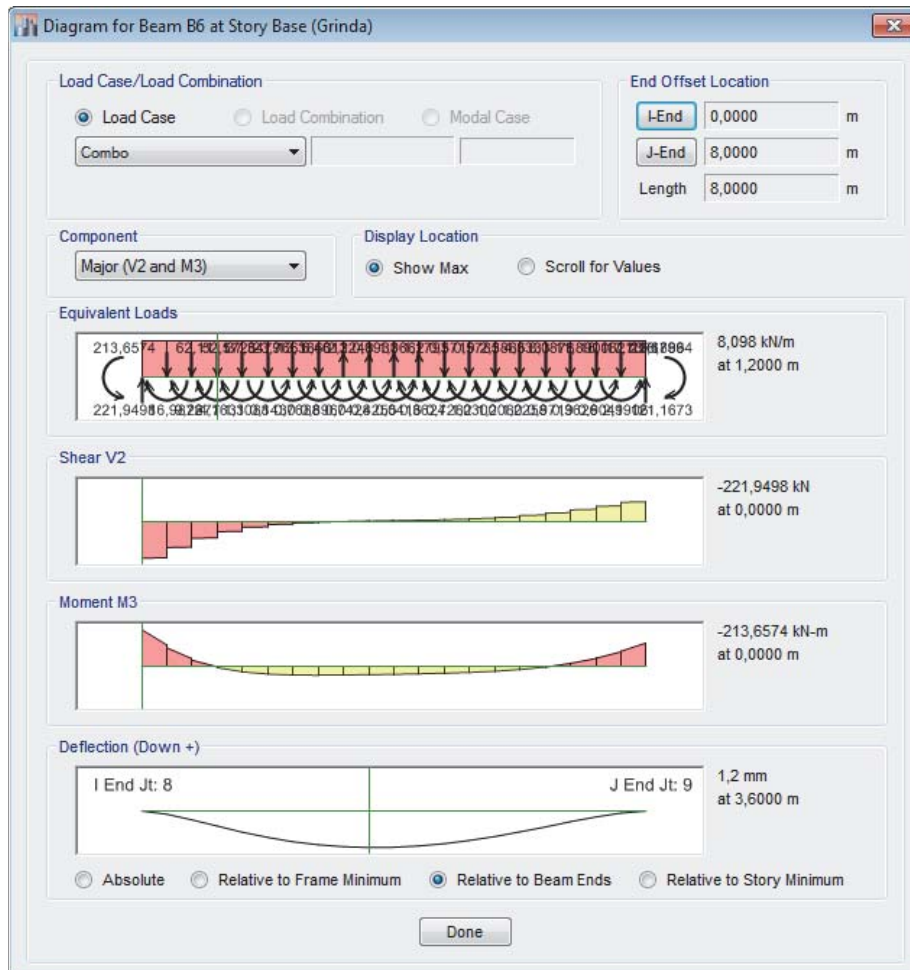
Fig. 11. The diagram and details for M33-2 – Load case combining maximum value of V22 and M33, $8,098\text{ kN/m}$ as equivalent loads.

The problem is the four supports of the two diagonal beams. In those supports we have great efforts. If the bearings resist, it also resists the structure, but if one of the supports yields, it will obviously yield the structure of the slab. The yielding of a support due to external conditions is highly probable because they are exactly where the water, ice and snow are leaking from the cylindrical areas. Cracks and frost can weaken the support area.
