Safety assessment of arch dams based on dynamic in situ testing

DAN STEMATIU*⁎, RADU SÂRGHIUŢĂ⁎⁎, ALTAN ABDULAMIT⁎⁎

The present paper section deals with the field testing of dynamic response of Paltinu arch dam and the corresponding calibrated model used to assess the dam safety or its deterioration due to aging phenomena.

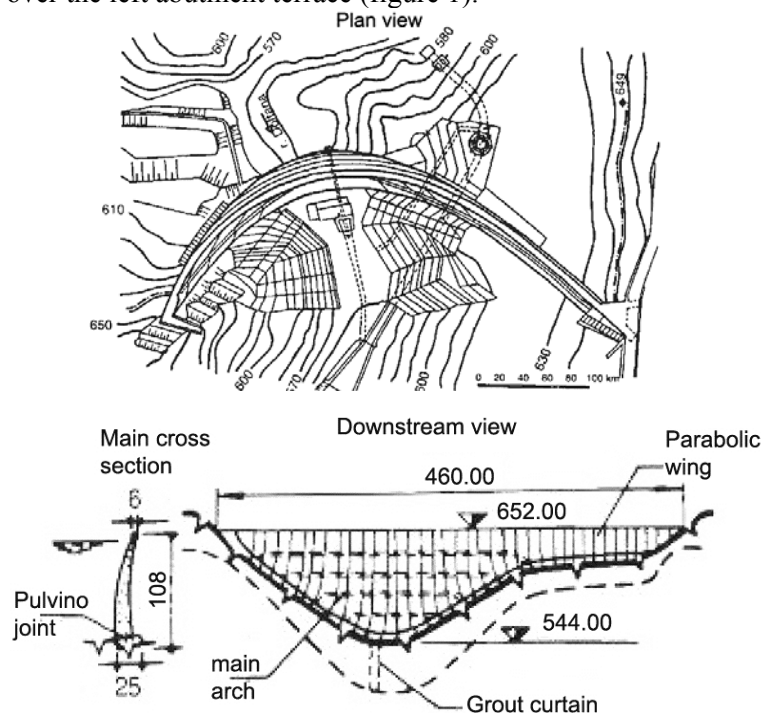
Fig. 1 Paltinu arch dam.

Located on Doftana River, Paltinu arch dam was constructed between 1960 and 1971. The dam height is of 108 m and the crest length is of 330 m. Storage has been purposed mainly to provide the discharge for drinking and industrial water supply. Dam structure is made up of central symmetrical double curvature arch body that rests on a pulvino by means of a peripherical joint and a parabolic wing extending over the left abutment terrace (figure 1).

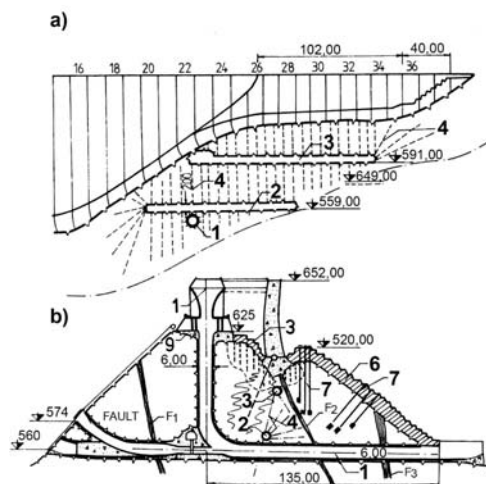
During the first 3 years after commissioning the reservoir was operated at lower levels. At the new cycle of reservoir filing in 1974 when the water levels have exceeded the previous recorded ones, an abnormal behavior of the dam was noticed: dam displacements larger than predicted, movements at the foundation level, joint openings, cracks at rock surface and significant increase of seepage (from 10 l/s to 150 l/s).

Fig. 2. Remedial works for Paltinu dam
a - longitudinal profile at the left bank; b - cross section along the bottom outlet
1   outlet gallery; 2 lower drainage gallery; 3 upper drainage gallery; 4 drainage drillings;
5 upstream concrete cover; 6 downstream concrete cover; 7 pre-stressed anchors.

Remedial works had in view the causes of the unusual loading scheme [7]. They consisted mainly of additional rock watertightening upstream the fault, drainage downstream and additional mass on the left abutment. To reduce the seepage forces within the rock mass the upstream face of the rock was covered with concrete and a new grout curtain was performed along the left abutment. To prevent possible water pressure effects a new drainage system was provided by means of two drainage galleries located 10 m downstream the grout curtain. To increase the abutment stability a concrete cover was performed on the left bank downstream area that allowed also rock mass consolidation by grouting and controlled drainage (figure 2, 3).

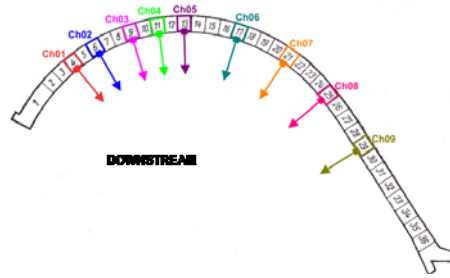
Fig. 5. Location of the sensors.

The location of seismometers used in the October 2017 campaign is shown in figure 5. Nine sensors were simultaneously positioned at the crest level, on the radial direction, on the horizontal tangential direction and on the vertical direction. The records have been carried out taking into account vibration sources as micro tremors, together with vibrations produced by turbines of the water power station at the dam toe.

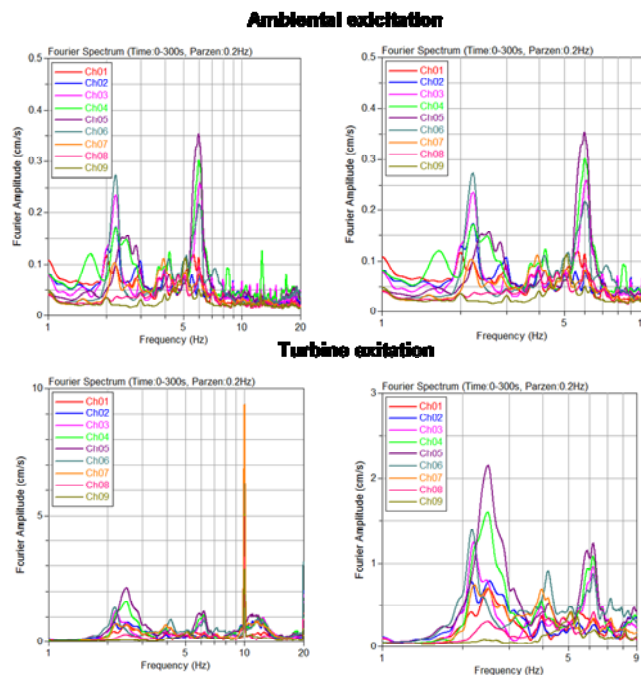
The processing of the data was carried out digitally, which allowed the determination of mean values, peak-peak values, Fourier spectra and response power spectral densities. The Fourier spectra based on the multi-channel records along the radial direction at the nine measuring points (ch01 --- ch09) are presented in figure 6.

Fig. 6. Fourier spectra for some of the recorded displacements.

Based on the field measurements the first – fundamental period of vibration was identified as being T1 = 0.44 sec (f_1 = 2.26 Hz). The dynamic properties rendered

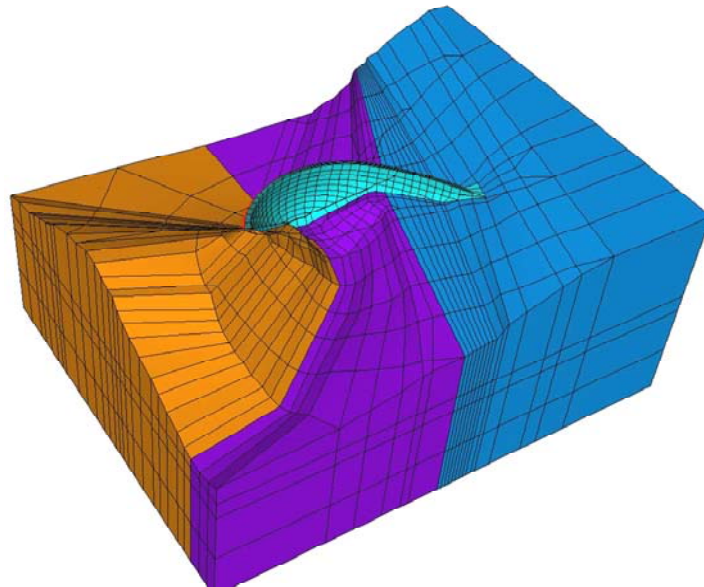
Fig. 7. The finite element model.

A 3 D finite element model of the dam – foundation system was developed using the ANSYS computer program (see figure 7). The dam-foundation interaction effects were represented by a "*standard*" massless foundation model, in which only flexibility of the foundation rock is considered but its inertia and damping are ignored. The rock foundation was modelled with 2780 solid elements connected in 3510 nodes. The arch dam was modelled as a monolithic structure represented by 574 of finite elements of appropriate types. The dam-water interaction effect was represented by the added hydrodynamic mass models according to Westergaard. The added water mass is realized by means of 173 lumped mass elements at the upstream face of the dam. The sensitivity analysis leads to a concrete elasticity modulus of 25×10^6 kPa corresponding to the measured fundamental frequency.

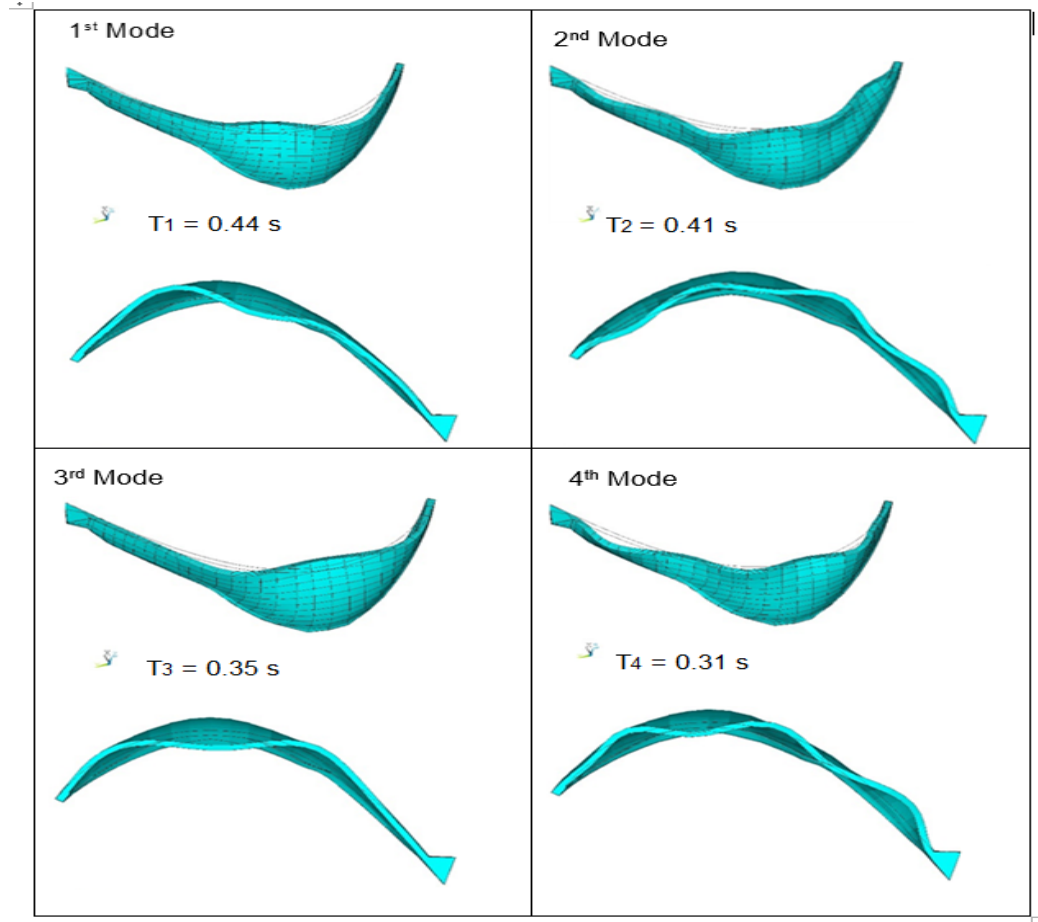
Fig. 8. The first four vibration modes of the FE model.

modes of vibration were presented in the form of deflected shapes (figure 8).

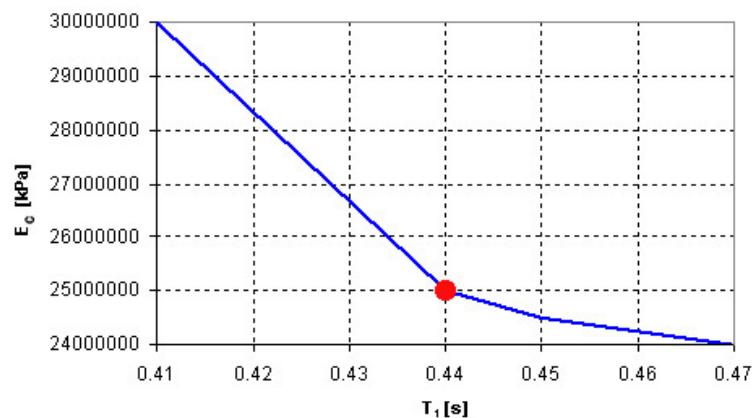
In the case of Paltinu dam the calibration leads to a concrete elasticity modulus of 25×10^6 kPa corresponding to the measured fundamental frequency (figure 9).

Fig. 9. Calibration of the mathematical model by the fundamental period.

Based on annual campains of field measurements the calibration process is renewed. If the new values of the elastic modulus do not differ significantly from the previous value one can conclude that the dam has preserved its structural properties. If this is not the case, further investigation are required.
