## Journal of Engineering Sciences and Innovation

Volume 3, Issue 4 / 2018, pp. 375 - 392

## Guaranteed versus real service life of PV panels in Romania

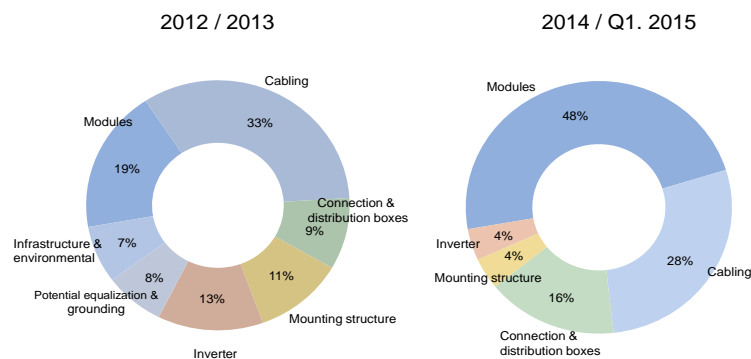
market for qualification, certification of photovoltaic power plants and solar product certification, has the most extensive expertise on the behaviour of PV modules over time (over 30 years of experience) on all continents (over 12GW of power plants inspected) [4]. In the report regarding the Quality Assurance and Risk Management of Photovoltaic Projects [4], based on the study of more than 100 PV plants (100 kWp - 30 MWp) located in different regions of Europe and divided into two periods (2012-2013/2014 - Q1.2015), TUV Rheinland makes a statistic of the particularly serious defects of photovoltaic power plants, for which immediate action is needed to prevent the power plants from being switched off (fig. 2).

First of all, it can be observed that the main problems are caused by the PV modules and secondly that the share of faulty modules has increased significantly during 2014-2015. This can lead to the conclusion that the experience of inverter manufacturers has increased, their reliability has improved, the experience of builders and installers has increased, while the reliability of the modules has remained the same or even dropped. The competition on the photovoltaic market, where Asian companies are ranked first (8 out of 10 are Chinese companies), has led module makers to boost productivity and dropping the costs so they can lower the sales price. Although productivity growth is also based on technology development, it has focused less on increasing the life of the products. The cost reduction went in two directions: increasing the efficiency of PV cells (prices are always expressed in currency / W) and cheaper raw materials production. However, none of these development policies also mean an increase in product quality, but on the contrary, increased productivity generates major challenges in quality assurance. All the world's top manufacturers boosted production capacities well above 1GW per year. A production rate of only 1 GW per year means a production of approximately 11500 PV modules per day. It is very difficult to ensure quality check procedures on the production line for such a large volume. Each module must have the I-V characteristic and power output determined at the factory as well as electroluminescent tests. Concerns about quality and longevity are considered by several companies and institutes in Europe such as Dupont and Fraunhofer.

Fig. 2. Serious defects for which immediate corrective maintenance is required.

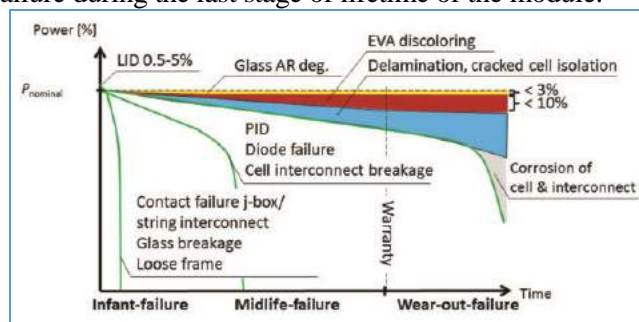
The aging and malfunctioning mechanisms observed over the last decades have been studied across a wide range of locations and sets of different materials. Defects may be due to material quality, defective product design, or due to quality control failure in the manufacturing line. The figure 3 below shows the aging mechanisms and malfunction defects of the module that occur in the three stages of service life: infant failure in the first 4-5 years, midlife failures of up to 10-12 years (the warranty) and the wear-out failure during the last stage of lifetime of the module.

Fig. 3. Degradation of PV modules in time.

Early faults occur at the beginning of the PV module service life. The causes origins are usually: faulty construction, production defects and non-conforming materials. Interruption of the life cycle of up to 10-15 years of operation is called "mid-life failure", while at the end of the lifetime, wear effects of the PV module occur.

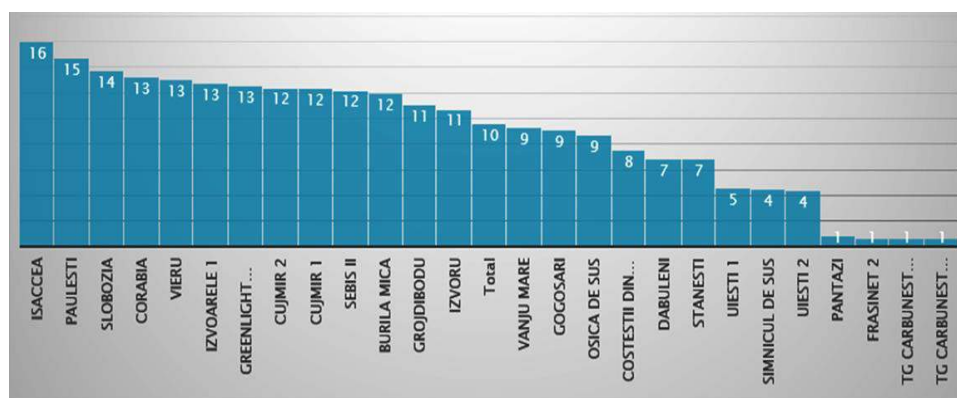
In Romania there are currently about 1400 MW installed in photovoltaic power plants, of which about 1100 MW were installed in 2013 and about 300 MW in 2014. We can assume that over 90% of the total capacity installed in the Romanian Photovoltaic Power Plants is in the transition from the infant to the middle stage of service life. Public information is available on the status of the dispatchable PV power plants on the Transelectrica S.A. website (power plants with a power of more than 5 MW). Thus, it was possible to extract the rated power for the PV plants that enters into production every year (listed quarterly) from the date of commissioning until the end of 2017. The power degradation in the first 5 years from commissioning is presented in Fig.5 for several PV power plants.

This diagram represents (with very few exceptions) the degradation rate of the power of photovoltaic power plants taken into consideration. Power degradation above the allowed limit of 0.7% per year - is relevant for 23 power plants out of a total of 27 commissioned in 2013. Figure 6 shows the duration, measured in years, when power degrades to 80 % of the rated power (blue curve) based on the annual degradation rate of the panels. The diagram present also the degradation curve for 90% (orange curve) and 95% (gray curve) [6].

Fig. 5. The nominal power decrease rate (in percentages) for the PV power plants commissioned in 2013 in Romania.

If we choose from Fig.5 rates with a total degradation exceeding 10% divided by 5 (number of years of operation), it can be found that 14 power plants exceed the rate of 2%. Following this percentage on the blue line in Fig. 6 it can be observed that in order to reach 80% of the nominal power will be necessary only 10-12 years of operation. In other words, these panels will reach 80% of the nominal power in 5-7 years from now. On the other hand, manufacturers guarantee 80% of the rated power, stated on the label, for at least 25 years from commissioning. In this case, losses are very high and should worry investors. Despite this situation, with rare exceptions, they are not concern because the subsidy awarded cover the expenses, thus recovering the investment in the first 5 years.

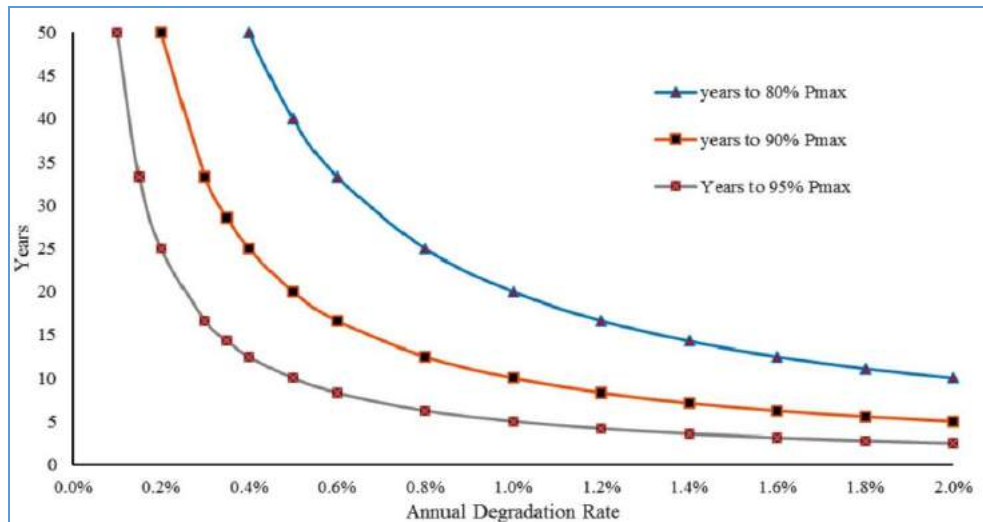
Fig. 6. Run time of a module up to the degradation limit of 80% of the rated power, 90% and 95%, depending on its annual rate of degradation.

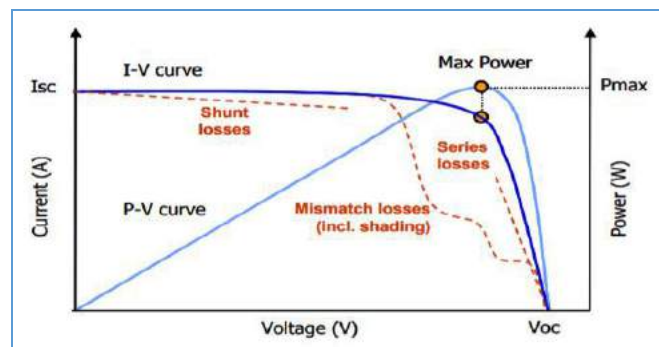
Fig. 7. I-V characteristic curve.

This type of diagram provides relevant information about the status of photovoltaic panels. A deviation of the dotted line can be caused by: one or more destroyed cells, a defective bypass diode or signs of Potential-induced degradation (PID). The shape of the current-voltage characteristic (IV), compared to the IV-rated or pre-delivered characteristics (flash-test), gives us information that mostly covers the entire range of defects appearing in silicon photovoltaic modules [7].
