Journal of Engineering Sciences and Innovation

Volume 3, Issue 4 / 2018, pp. 375 - 392

Guaranteed versus real service life of PV panels in Romania

4. Results of inspections and measurements carried out in PV power plants in Romania

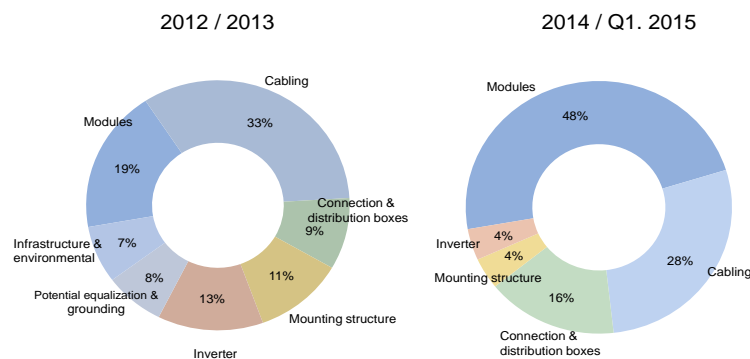
market for qualification, certification of photovoltaic power plants and solar product certification, has the most extensive expertise on the behaviour of PV modules over time (over 30 years of experience) on all continents (over 12GW of power plants inspected) [4]. In the report regarding the Quality Assurance and Risk Management of Photovoltaic Projects [4], based on the study of more than 100 PV plants (100 kWp - 30 MWp) located in different regions of Europe and divided into two periods (2012-2013/2014 - Q1.2015), TUV Rheinland makes a statistic of the particularly serious defects of photovoltaic power plants, for which immediate action is needed to prevent the power plants from being switched off (fig. 2).

First of all, it can be observed that the main problems are caused by the PV modules and secondly that the share of faulty modules has increased significantly during 2014-2015. This can lead to the conclusion that the experience of inverter manufacturers has increased, their reliability has improved, the experience of builders and installers has increased, while the reliability of the modules has remained the same or even dropped. The competition on the photovoltaic market, where Asian companies are ranked first (8 out of 10 are Chinese companies), has led module makers to boost productivity and dropping the costs so they can lower the sales price. Although productivity growth is also based on technology development, it has focused less on increasing the life of the products. The cost reduction went in two directions: increasing the efficiency of PV cells (prices are always expressed in currency / W) and cheaper raw materials production. However, none of these development policies also mean an increase in product quality, but on the contrary, increased productivity generates major challenges in quality assurance. All the world's top manufacturers boosted production capacities well above 1GW per year. A production rate of only 1 GW per year means a production of approximately 11500 PV modules per day. It is very difficult to ensure quality check procedures on the production line for such a large volume. Each module must have the I-V characteristic and power output determined at the factory as well as electroluminescent tests. Concerns about quality and longevity are considered by several companies and institutes in Europe such as Dupont and Fraunhofer.

Fig. 2. Serious defects for which immediate corrective maintenance is required.

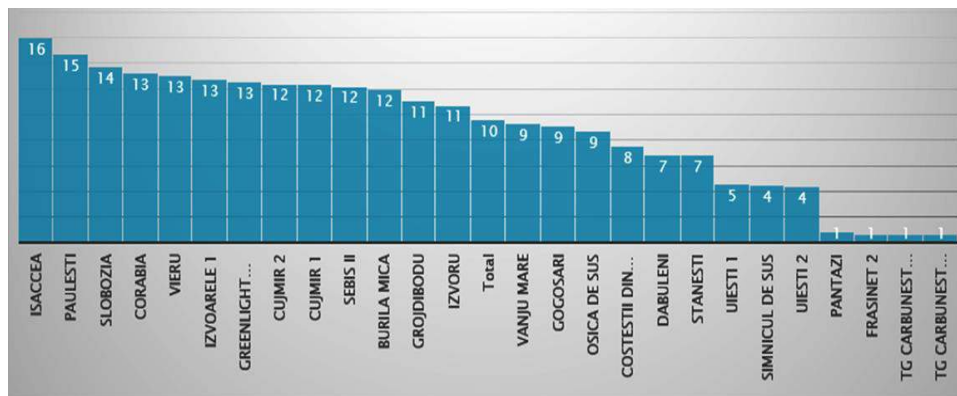
This diagram represents (with very few exceptions) the degradation rate of the power of photovoltaic power plants taken into consideration. Power degradation above the allowed limit of 0.7% per year - is relevant for 23 power plants out of a total of 27 commissioned in 2013. Figure 6 shows the duration, measured in years, when power degrades to 80 % of the rated power (blue curve) based on the annual degradation rate of the panels. The diagram present also the degradation curve for 90% (orange curve) and 95% (gray curve) [6].

Fig. 5. The nominal power decrease rate (in percentages) for the PV power plants commissioned in 2013 in Romania.

If we choose from Fig.5 rates with a total degradation exceeding 10% divided by 5 (number of years of operation), it can be found that 14 power plants exceed the rate of 2%. Following this percentage on the blue line in Fig. 6 it can be observed that in order to reach 80% of the nominal power will be necessary only 10-12 years of operation. In other words, these panels will reach 80% of the nominal power in 5-7 years from now. On the other hand, manufacturers guarantee 80% of the rated power, stated on the label, for at least 25 years from commissioning. In this case, losses are very high and should worry investors. Despite this situation, with rare exceptions, they are not concern because the subsidy awarded cover the expenses, thus recovering the investment in the first 5 years.

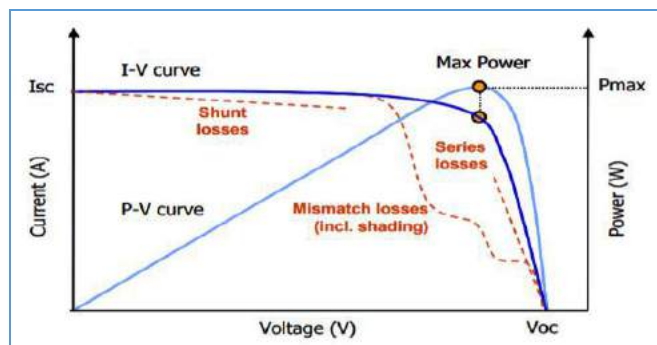
Fig. 7. I-V characteristic curve.

This type of diagram provides relevant information about the status of photovoltaic panels. A deviation of the dotted line can be caused by: one or more destroyed cells, a defective bypass diode or signs of Potential-induced degradation (PID). The shape of the current-voltage characteristic (IV), compared to the IV-rated or pre-delivered characteristics (flash-test), gives us information that mostly covers the entire range of defects appearing in silicon photovoltaic modules [7].
