Journal of Engineering Sciences and Innovation

Safety of a historical Dam in Romania

DAN STEMATIU^{1*}, ALTAN ABDULAMIT²

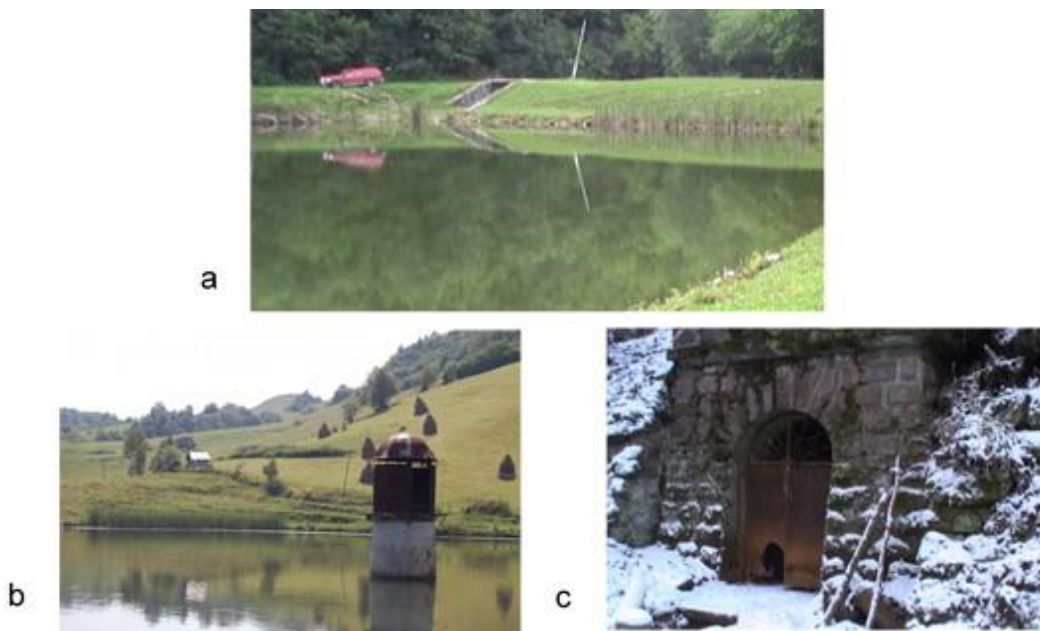
Fig. 4. Taul Mare Dam appurtenant structures;
a – spillway; b – bottom outlet tower intake; c – bottom outlet gallery exit portal.
