Journal of Engineering Sciences and Innovation

Volume 4, Issue 4 / 2019, pp. 399-410

# Romania's contribution to the development of the knowledge society in the field of nuclear energy research

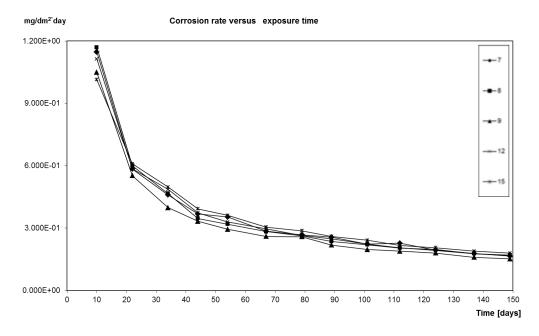
The corrosion kinetics of the Zr-2.5% Nb material is shown in Fig.3.

From the plotted graphs it is observed that the corrosion rates decrease as the test time increases.

After a short initial period in which the oxidation is carried out according to different speed laws, the corrosion (weight gain  $\Delta W$  due to the formation of the oxide layer) follows a cubic shape relation:

Fig. 3. Corrosion kinetic for Zr-2.5%Nb.

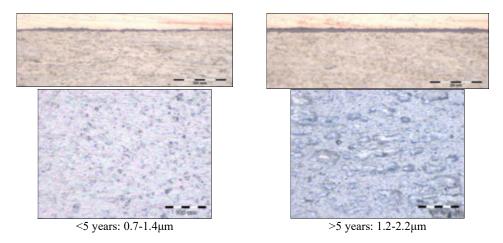
The zirconium alloy coupons (Zr-2.5% Nb), identified as Y4 - 47 and Y2 - 62 were extracted from the Y4 autoclave, at the exit of the reactor (at the steam generator); respectively Y2 autoclave at the reactor inlet (at recirculation pump) and thus the test conditions are different. The coupons subjected to the examination also had different exposure periods in the specific environment, the coupon Y4 - 47 being extracted after a period of less than 5 years, and the coupon Y2 - 62, after an exposure period of more than 5 years. At the visual examination of the coupons from Zr-2.5% Nb, there were differences between the two coupons regarding the surfaces of the formed oxides. The results obtained by optical metallographic microscopy are presented in the Fig. 4.

Fig. 4. The aspect of oxide films and surface morphology formed on Zr-2.5%Nb after different periods of exposure in the PHTS autoclaves system.

Coupon Y2 - 62 has a glossy black oxide and numerous white lines along the length of the coupons. This suggests that, before mounting on the support, the coupon had traces of deep mechanical processing, which oxidized differently from the rest of the material. Generally, in the case of Zirconium alloys the white color of the oxide is specific to the stoichiometric oxide  $ZrO_2$ , and the black, gray color signifies the presence of a non-stoichiometric  $ZrO_{2-x}$  oxide.

In the case of coupon Y4 - 47 it was found that the surface is completely covered with a black, glossy oxide, Fig.5 and Fig.6.
