Journal of Engineering Sciences and Innovation

CANDU steam generator secondary side fouling characteristics

Abstract. In the process of the equipment degradation in the secondary circuit of a CANDU plant an essential role is played by the formation, transportation and deposition of corrosion products and impurities. Minimizing the presence of these corrosion products in a key equipment, such as the steam generator, is a determining factor in ensuring optimum operation in safe conditions and without the risk of unplanned plant shutdowns resulting in direct and indirect economic costs. Through its objective, this work is an opportunity to characterize the chemical composition of the deposits removed from the Cernavoda NPP steam generator secondary side by a scheduled shutdown and to synthesize the main information from the specialty literature in the field of degradation of the steam generator tube - tubesheet joint regions.

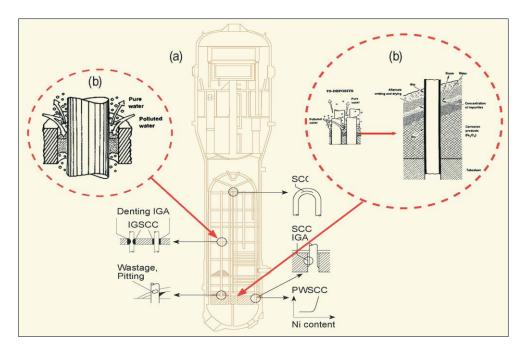
Fig. 1. The mechanism of concentration of the impurities in steam generators (a, b); areas affected by corrosion in steam generators (b).

The presence of deposits in the crevices contributes to the concentration of aggressive chemical species within these crevices and therefore contributes to limiting the life of the steam generator, Fig. 1.

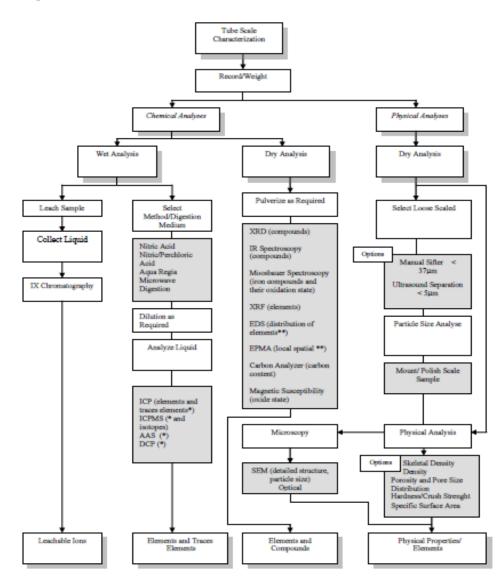
Fig. 2. Characterization of powder deposits.

them in recipients with lids. The amount of powder in each container was determined according to the type of analysis applied. The characterization of deposits consists in sampling, identification, carrying out of laboratory analyzes and the interpretation of the data that is necessary for assessing the effects of deposits developed on the structural materials of the steam generator and for the operation of this key equipment, Fig. 2.

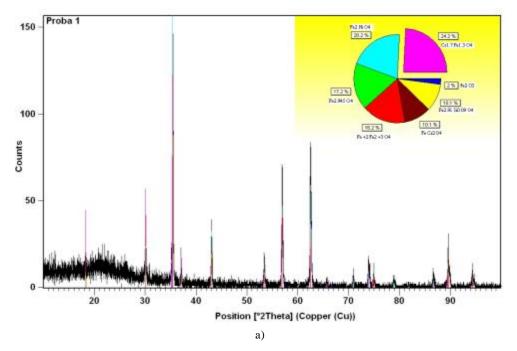
Fig. 3. The diffraction spectrum for sample 1 (a).

X-ray diffraction analyzes were performed using the X'Pert PRO MPD X-ray diffractometer, equipped with an X-ray tube (Line Fine Focus - 12x0.4mm) with Cu anode.

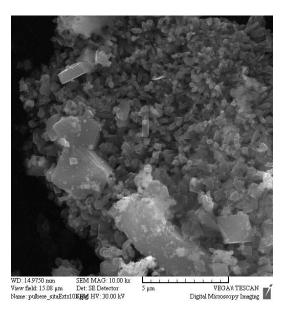
Fig. 4. The deposits morphology determined by SEM.

Fig. 4 shows the morphology of deposits determined by Scanning Electron Microscopy.

The magnetite crystals have rounded edges and this is being explained by the fact that they have not formed inside the steam generator but inside the secondary circuit from where they were transported to the steam generator and because of the flow, the edges have been rounded. Iron is in different oxidation states, darker crystals contain more oxygen in the formula, while lighter crystals contain less oxygen. Particle sizes range from a few microns to tens of microns. In Fig. 5 are presented the point microanalysis (a), the spectra and the quantitative composition of the deposit (b) and (c), which show the presence of Fe – 85.63%, Mn – 10.15% (this may come from the austenitic steels corrosion process) and Si - 3.19%. The presence of silicon in deposits must be followed with great care as it gives hardness to deposits and therefore deposits will be more difficult or impossible to remove from the steam generator by simply cleaning with a pressure water jet, [7] \div [23]. The form of the deposit constituents confirms the presence of both magnetite and hematite and rarely the presence of chromium compounds (oxides and carbides). There are several types of oxides that differ in atomic form and number.

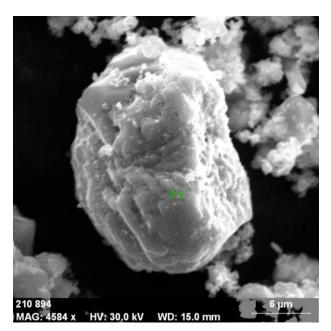
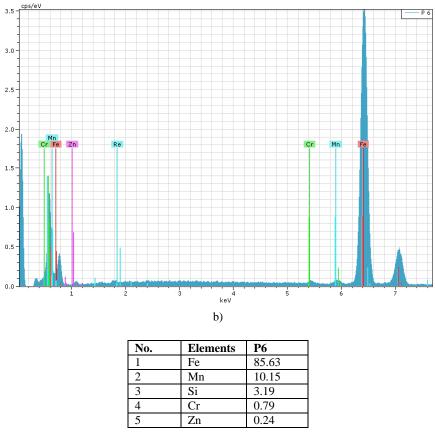
Fig. 5. Point microanalysis (a), spectrum and quantitative composition of deposits (b) and (c).
