Study of the wear behavior of bronze coatings deposited by the EAS method

**CORNELIU MUNTEANU^{1,2*}, CRISTIAN STESCU¹, DANIELA CHICET¹,
IOAN VIDA-SIMITI^{2,3}, BOGDAN ISTRATE¹, IOAN DOROFTEI¹,
RAUL GEORGE CIUBOTARIU¹**

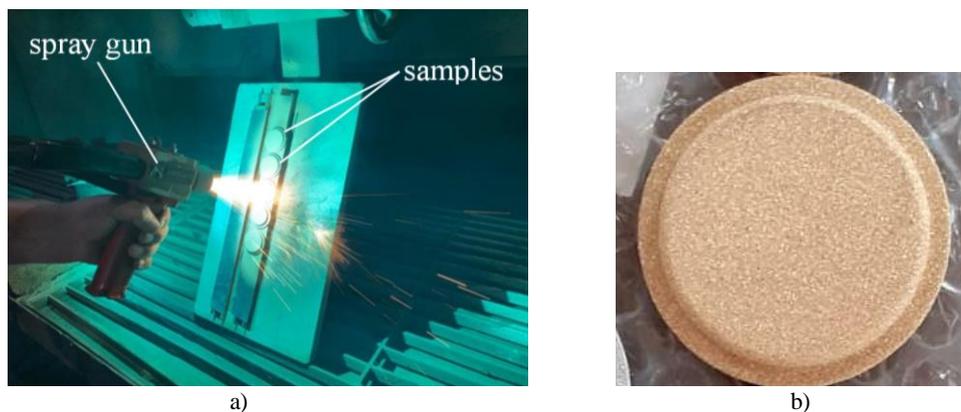
Fig. 1. Aspects of: a) electric arc deposition process; b) as-coated sample S1.

The first sample (S1) is a thermal coated sample, produced by electric arc deposition method (see Fig. 1a) with a Cu-Al 90-10 commercial wire manufactured by FST Netherland, with a nominal composition of 10 wt% Al and 90 wt% Cu. The thermal spraying parameters were: output voltage - 30-32 V, output amperage - 200 A, spray distance - 150 mm. The substrate used for the coating is realized from low alloyed steel, which chemical composition is presented in Table 1.

As presented in Fig. 1b, the as-sprayed sample S1 has a rough aspect, specific to the one obtained by thermal coating. For the microstructure analysis of the coating, one of the samples was cross-sectioned and prepared by resin embedding, polishing, etching and observed using an optical microscope (OM). The microstructure of the coating is presented in Fig. 2. It has a thickness between 280 - 328 μm and a lamellar structure resulted after the stacking and rapid solidification of the molten or semi-molten droplets of bronze, accelerated toward the substrate during the thermal spray process.

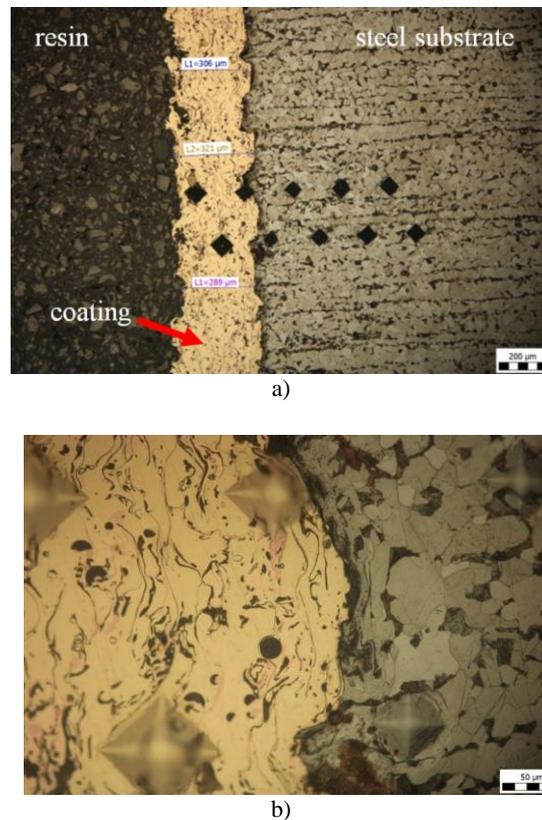
Fig. 2. Microstructural (OM) aspects of the S1 cross-section at various magnifications: a)50x, b)400x.

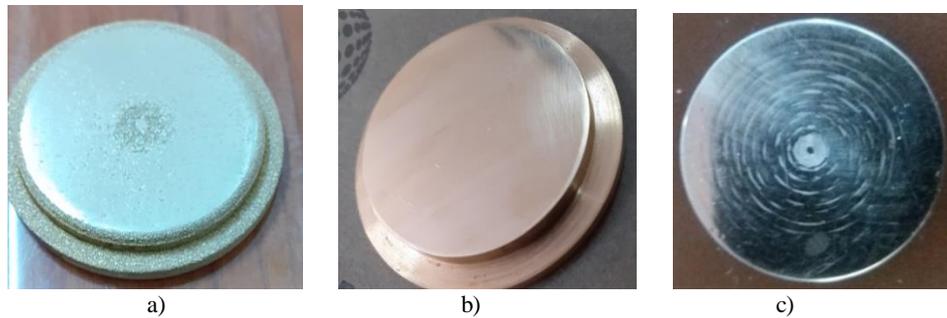
Fig. 3. Aspects of polished samples: a) S1 ; b) S2; c) S3.

Before the wear tests, all the samples were finished using sandpapers of various grit and lapping (as presented in Fig. 3), to obtain a comparative roughness of the inner side of the cam rings, as close as possible to the one used in mass production, $R_z = 0,3 \mu\text{m}$ accordingly to [20]. The roughness of the samples and disc was obtained as the arithmetic mean values of three identical measurements with the Form Talysurf 50 stylus Profilometer (Taylor Hobson, UK), and the results are presented in Table 2.

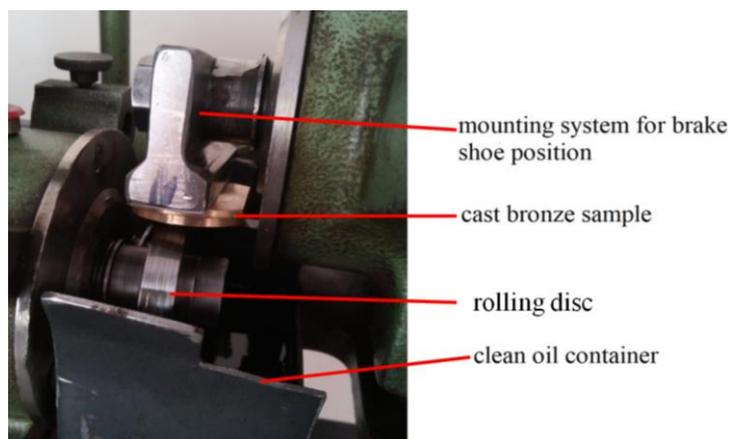
Fig. 4. Detailed aspect of the wear testing system (on Amsler type machine).

The sliding wear tests were conducted on an Amsler type testing machine („two-disc machine”), which is successfully used for testing the rolling and sliding wear of various materials under a wide variety of testing conditions. The Amsler tribometer is a type A 135 commercially apparatus produced by Wolpert Werkstoffprüfmaschinen GmbH. in Switzerland and is located in the Faculty of Mechanics (Technical University of Iasi, Romania). The testing conditions used for this study were as follows: samples S1, S2 and S3 were mounted in the upper side (with a brake shoe role), in a fixed position obtained by interrupting the gears transmission chain [21]. The rotating disc is mounted in the lower part of the system (see Fig. 4) and is made of bearing steel AISI 52100 characterized by a hardness of 60-64 HRC. The disc has a thickness of 10 mm, a radius of 29.5 mm, both on radial and axial directions and a finished surface which roughness is presented in TABLE 2. After each test, the rolling disc was polished in order to maintain the initial Rz roughness around $0.9 \mu\text{m}$. The tests were performed in a greased environment, in the conditions of a clean fluid, the rolling disc being immersed in the lower half part, in a container filled with oil (Castrol ATF Multivehicle), with the following characteristics: relative density (at 15°C) of 0.85 g/ml and kinematic viscosity (40°C) of $35 \text{ mm}^2/\text{s}$.

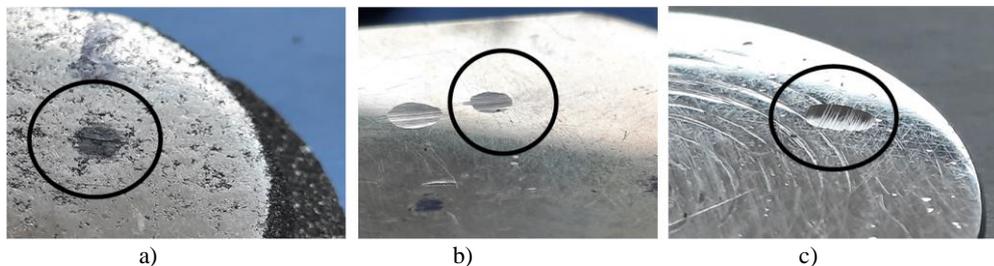
Fig. 5. Wear mark aspect of:
a) bronze coated sample S1, b) bronze as-cast sample S2, c) bearing steel sample S3.

After the tribological tests were performed, the aspect of the wear paths were observed, directly, for each sample. It was noticed that in each case a „spot” with different dimensions appeared, which means that all the surfaces were affected by the sliding wear. Fig. 5 a,b,c presents the resulted wear spots, marked with dotted line for each sample.

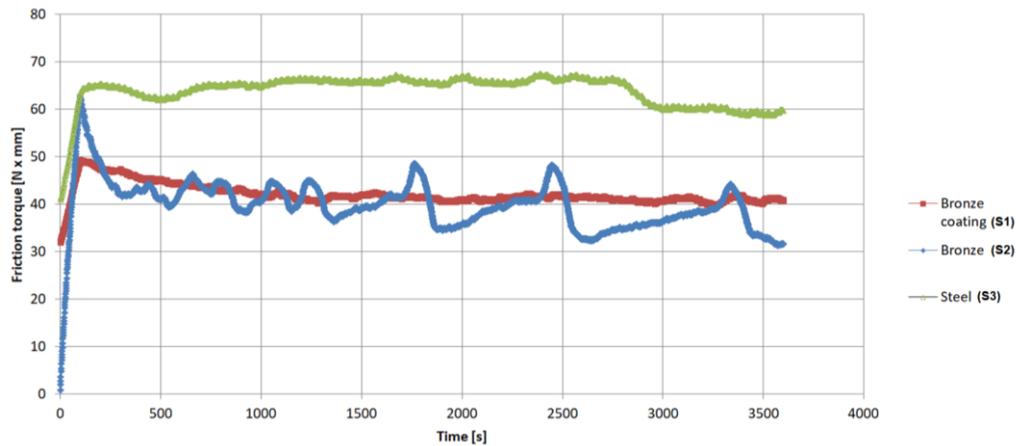
Fig. 6. Friction torque versus time.

Another aspect that must be taken into account when interpreting the friction tests is the appearance of the curves of variation of the friction moment. As seen in Fig. 6, the smallest variations are registered in the case of sample S1, followed by sample S3 and finally by sample S2, which generated a stick-slip variation curve.

Taking into account these aspects that are specific to a sliding motion regime with periodic interruptions, we could conclude that we are dealing with a mixed lubrication regime, specific to more rough friction couplings, loaded and operating at relatively low speeds. In this case a thicker layer of lubricant is formed, which is pierced by the roughness of the surfaces in contact, so that it is formed simultaneously with thick film lubrication and areas with thin lubricant film, pierced by the highest roughnesses. This can also explain the behavior of the S2 sample, which, although has a very low initial roughness, registers a friction peak in the first 200 seconds (64 N·mm) when the wear spot is formed, following the break-in condition of the surface of the bronze piece worsening. This was followed by an abrupt decrease in the friction moment value and a stick-slip behavior due to the adhesion processes between the micro-irregularities of the surfaces in contact, with a slightly descending slope with values between 30 - 40 N·mm. In the case of the S3 sample it is observed that the variation is much less intense, but the values are much higher than in the previous cases. The moment of friction had a steep increase in the first 100 seconds to about 65 N·mm, followed by a moderate increase in the value between 65 - 70 N·mm (2800 seconds) and a decrease to the value of 60 N·mm until the end of the test.

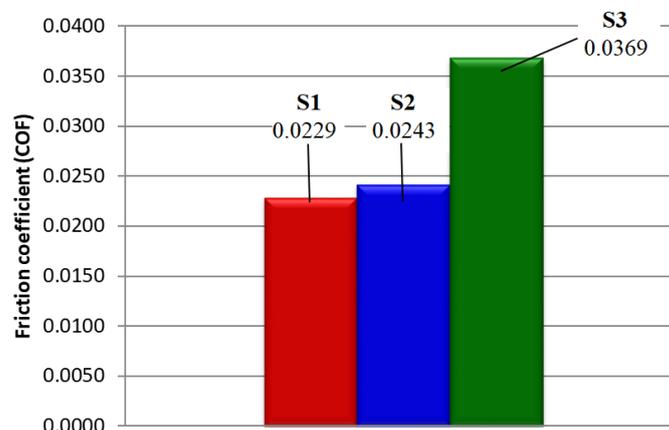
Fig. 7. Mean values of friction coefficient.

The friction tests were conducted on the AMSLER type machine, in wet conditions, at constant load and speed. The evolution of the friction torque in time was recorded with a data acquisition system and the values were post-processed with LabVIEW software, in order to obtain the mean values of the friction coefficients. As presented in Fig. 6, the friction torque of samples S1 and S2 had a higher value at the beginning, which decreased after the first 200 seconds, but with a lower value than the overall friction torque of the sample S3. The lowest friction coefficient was recorded for sample S1, but very similar with the one of the S2

sample and smaller than the one of the steel samples, as presented in Fig. 7.

These results must be interpreted taking into account the surface roughness of the samples, correlated with their morphology and the test environment. Thus, even if the roughness of S1 sample is much higher than that of S2 samples, respectively S3, the first one has a lamellar structure, slightly porous, specific to the layers made by thermal spraying. Given that the environment in which friction occurs is wet (power steering oil *Castrol ATF Multivehicle*) the low value of CoF can be explained by the fact that micro-porosities act as lubricant reservoirs.

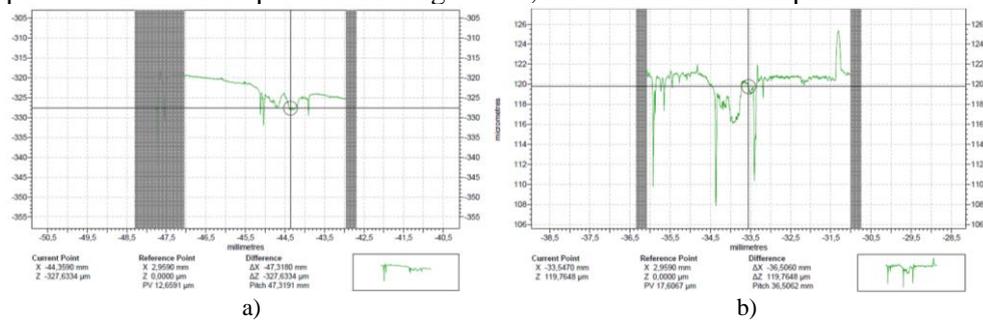
Fig. 8. Wear profiles of sample S1 in longitudinal direction (a) and transversal direction (b)

The wear assessment was performed by measuring the dimensions of the longitudinal and transverse wear spots, at the point of maximum depth. The wear profiles obtained are presented in Fig. 8 - 10, for each of the 3 samples.

The wear volume [21], [22] was calculated based on Eq (1) by approximating the wear mark with the geometry of a demi-ellipsoid whose half-axes a (longitudinal direction), b (transverse direction) and c (vertical direction) were measured on the raw profiles presented in Fig. 8 - 10.

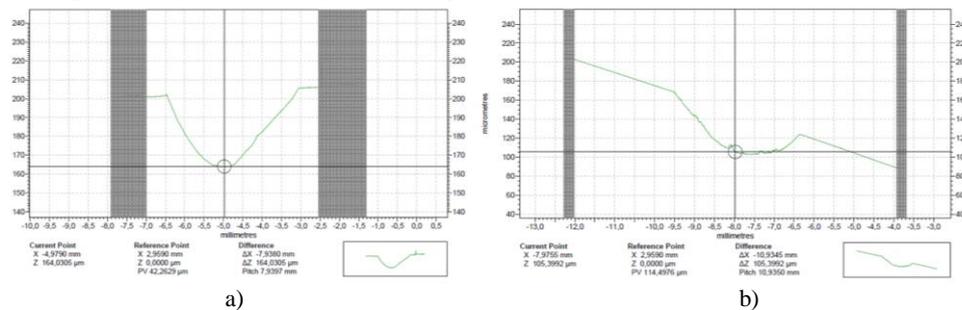
Fig. 9. Wear profiles of sample S2 in longitudinal direction (a) and transversal direction (b)

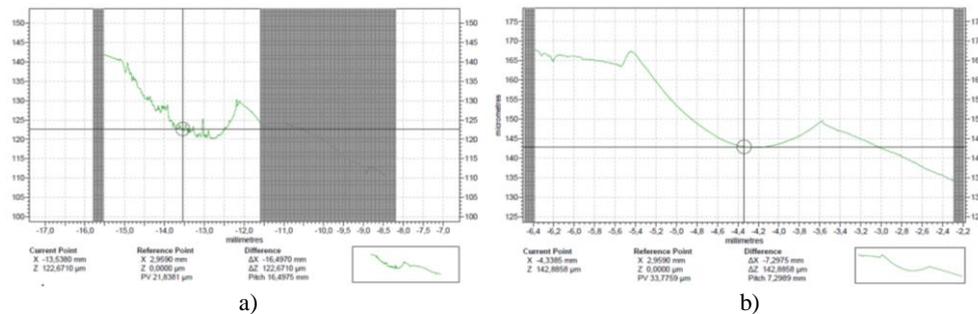
Fig. 10. Wear profiles of sample S3 in longitudinal direction (a) and transversal direction (b).

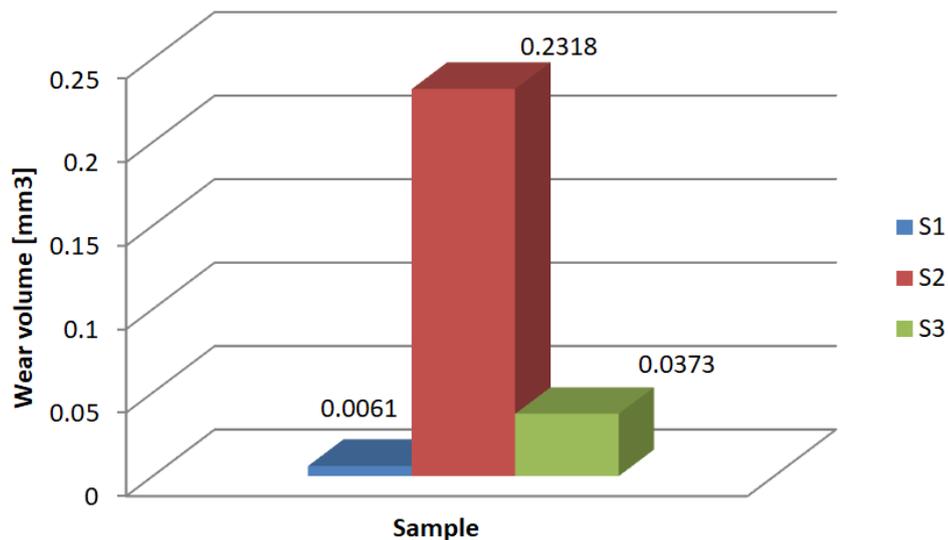
Fig. 11. Wear volume of tested samples.

For a clearer evaluation of the volume of material lost due to wear, the resulting values were represented graphically in Fig. 11. It is observed that the biggest volume loss is the one recorded in the case of sample S2, followed in ascending order by sample S3 and in end of test S1, the difference between each other being about an order of magnitude. These observations are consistent with the data presented above, regarding the variation of the friction moment, which indicates a high wear of the S2 sample, medium in the case of the S3 sample and very small in the case of the S1 sample. The reduced hardness of sample S2 led to significant

material losses, the variation curve of the friction moment indicating this phenomenon.
